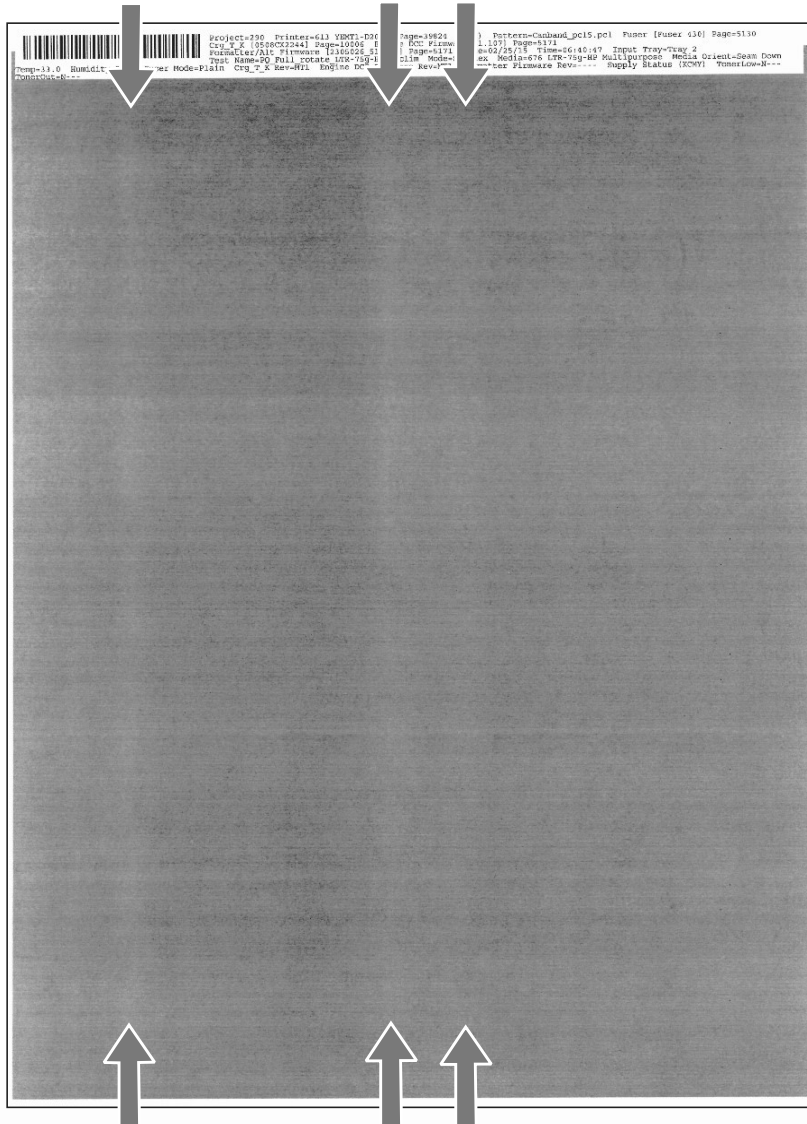
Figure 2-97 Vertical streaks - high temperature/humidity

Light streaks can appear and they usually span the length of the page. This problem is caused by toner clumping at the developer blade which reduces the amount of toner available for transfer at that page location. There is a stirring shaft inside the toner cartridge to reduce the severity of this defect. This defect appears in areas of fill, not in text.

This defect primarily occurs in high temperature and high humidity environments.

- Resend the print job.
- If the defect does not improve within two to three print jobs, remove the toner cartridge and gently rock it back and forth from side to side (this distributes the toner evenly in the toner cartridge).
- If the toner cartridge has reached the **Very Low** state, replace it.
- If the defect persists, replace the toner cartridge.

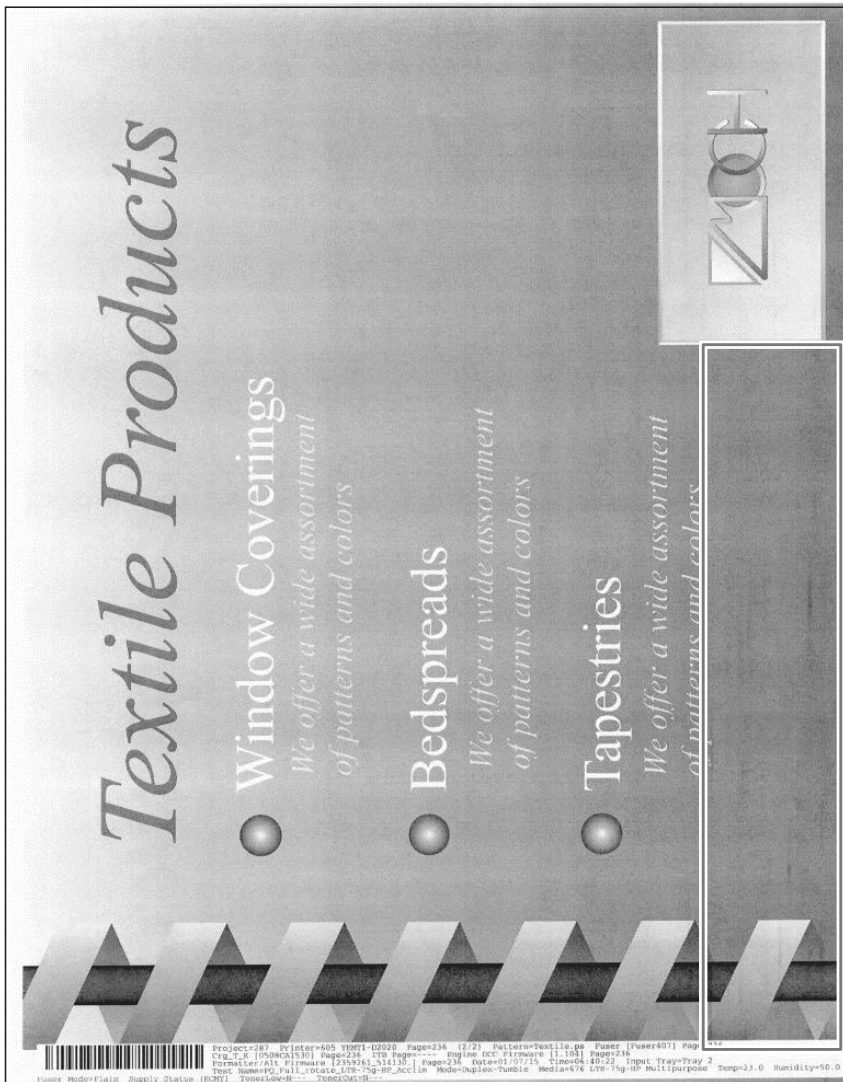
Figure 2-98 Dark streaks (early in toner cartridge life)

Smeared dark streaks come and go down the page, and are more common at the right and left edges of the page. This issue is caused by grease from toner cartridge stirring system contaminating the supply hopper which then causes the toner to cluster and results in dark streaks on the page. Countermeasures include optimizing grease: amount, position, and stickiness. This defect appears in areas of fill, not in text.

This defect occurs when using a new toner cartridge and usually decreases over toner cartridge life.

- Resend the print job.
- If the defect does not improve within two to three print jobs, remove the toner cartridge and gently rock it back and forth from side to side (this distributes the toner evenly in the toner cartridge).
- If the defect persists, replace the toner cartridge.

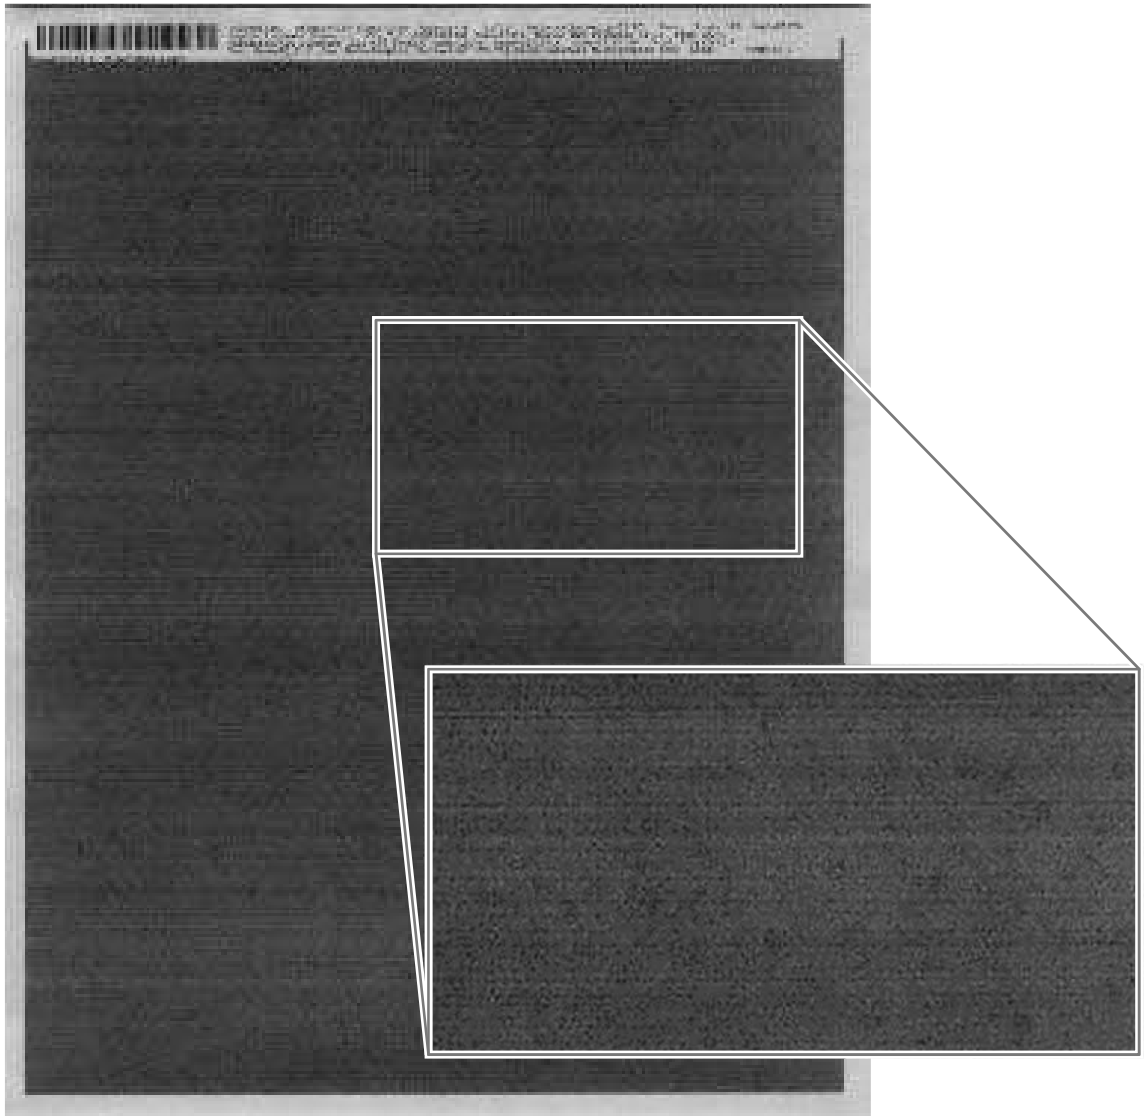
Figure 2-99 Fine-pitch banding

This defect appears as alternating light and dark (evenly spaced) repetitive horizontal lines. The 0.93 mm (0.03 in) fine-pitch banding is caused by the main drive motor gear tooth engagement. This defect appears in areas of fill, not in text.

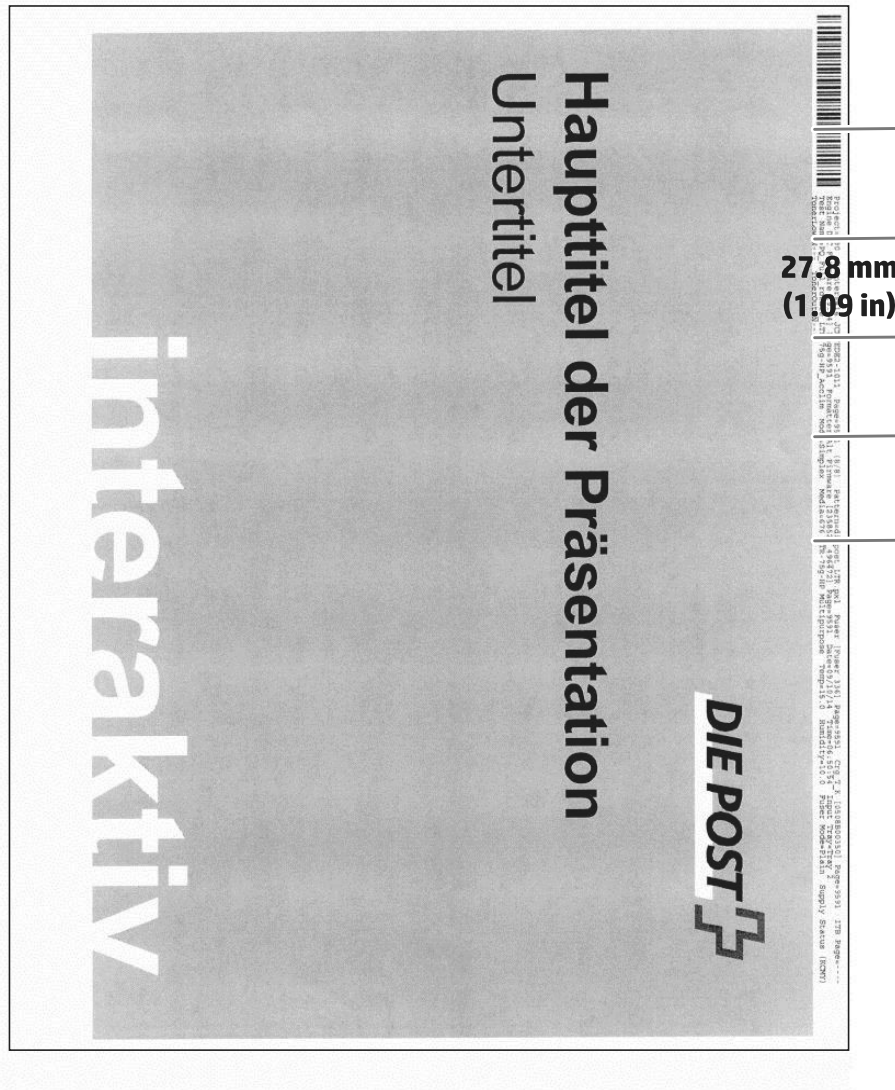
Figure 2-100 Wide-pitch banding

This defect appears as soft, gradual bands can be seen over a constant density area. It appears as slight gradients which repeat at approximately a 27.8 mm (1.09 in) pitch. This defect appears in areas of fill, not in text.

This defect is a density variation which appears on the PQ due to the gap variation between the OPC and the developer sleeve. This gap varies due to the accuracy of the OPC, developer sleeve, and the spacer placed between the OPC and the developer sleeve.

- Resend the print job.
- If the defect persists, replace the toner cartridge.

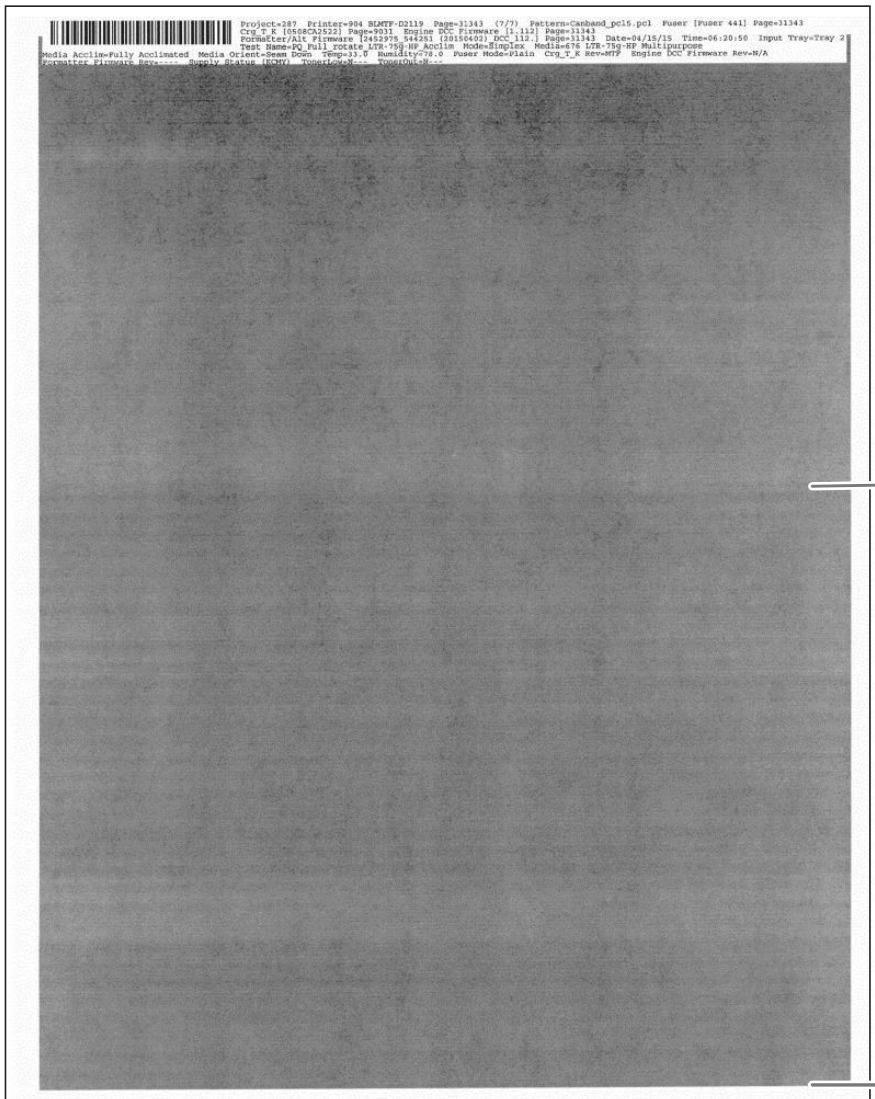
Figure 2-101 AC banding

This defect appears as alternating light and dark bands that repeat at 4.6 mm (0.18 in) pitch might be visible starting midway down the page in high-temperature and high-humidity environments. This defect is caused by the transfer current getting pulled into the fusing area through the paper from the fuser heater voltage supply. The transfer banding occurs at the power supply voltage frequency. A capacitor was added to the transfer front guide to improve the level as a countermeasure during development.

This defect usually occurs when printing in **Plain** print mode in high-humidity environments on fully acclimated (low resistivity) paper, which makes the transfer current flow to the fusing area more easily. The defect occurs more often with 220V units, which have higher impressed voltage to the fuser heater. This defect appears in areas of fill, not in text.

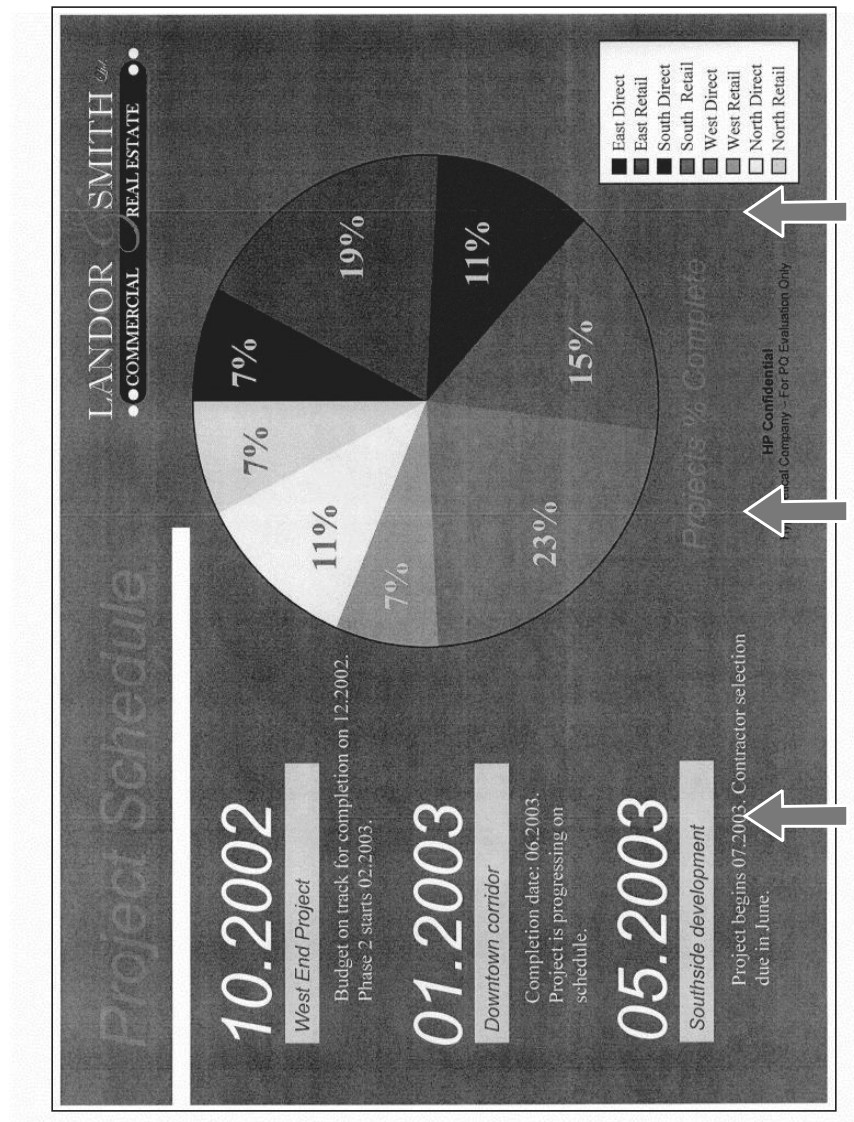
Figure 2-102 OPC sharp bands (version 1)

This defect appears as sharp bands which repeat at a 75mm (2.95 in) pitch down the page as a light/dark line. Waste products (for example, toner or paper) accumulate at the contact position between the C-blade and the OPC. When the OPC stops, the waste material can form a light attachment to the OPC. When the OPC begins to turn again, the material removal can affect the OPC charge for several rotations. This defect appears in areas of fill, not in text.

This defect might occur any time the toner cartridge is idle for long periods of time.

- Resend the print job. The defect should fade with subsequent printed pages.
- If the defect persists, replace the toner cartridge

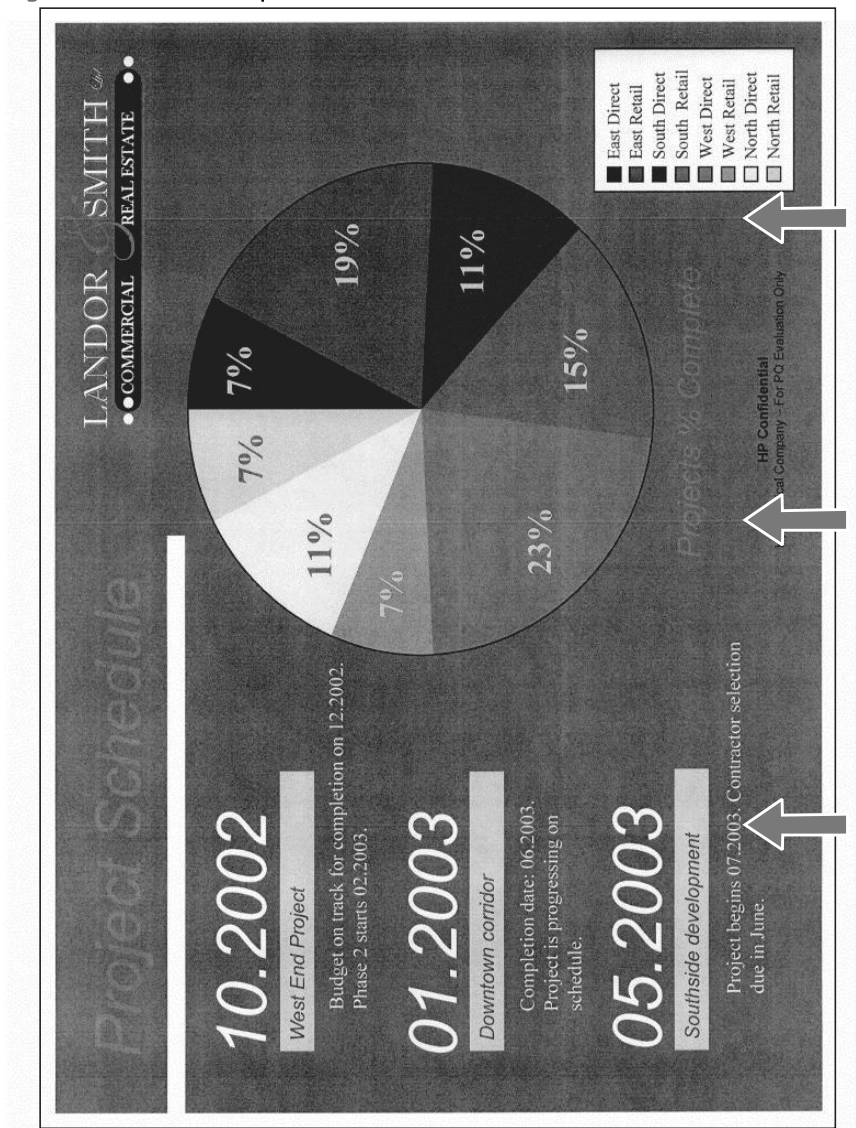
Figure 2-103 OPC sharp bands (version 2)

This defect appears as sharp bands which repeat at a 75 mm (2.95 in) pitch down the page as a dark line. The OPC drum is rubbed by the cleaning blade or charge roller due to vibration or impact. The rubbing effects the OPC charge but the defect fades with usage and time. This defect appears in areas of fill, not in text.

This defect can occur at the beginning of toner cartridge use, or if the cartridge is subject to vibration (for example, transportation).

- Resend the print job. The defect should fade with subsequent printed pages.
- If the defect persists, replace the toner cartridge

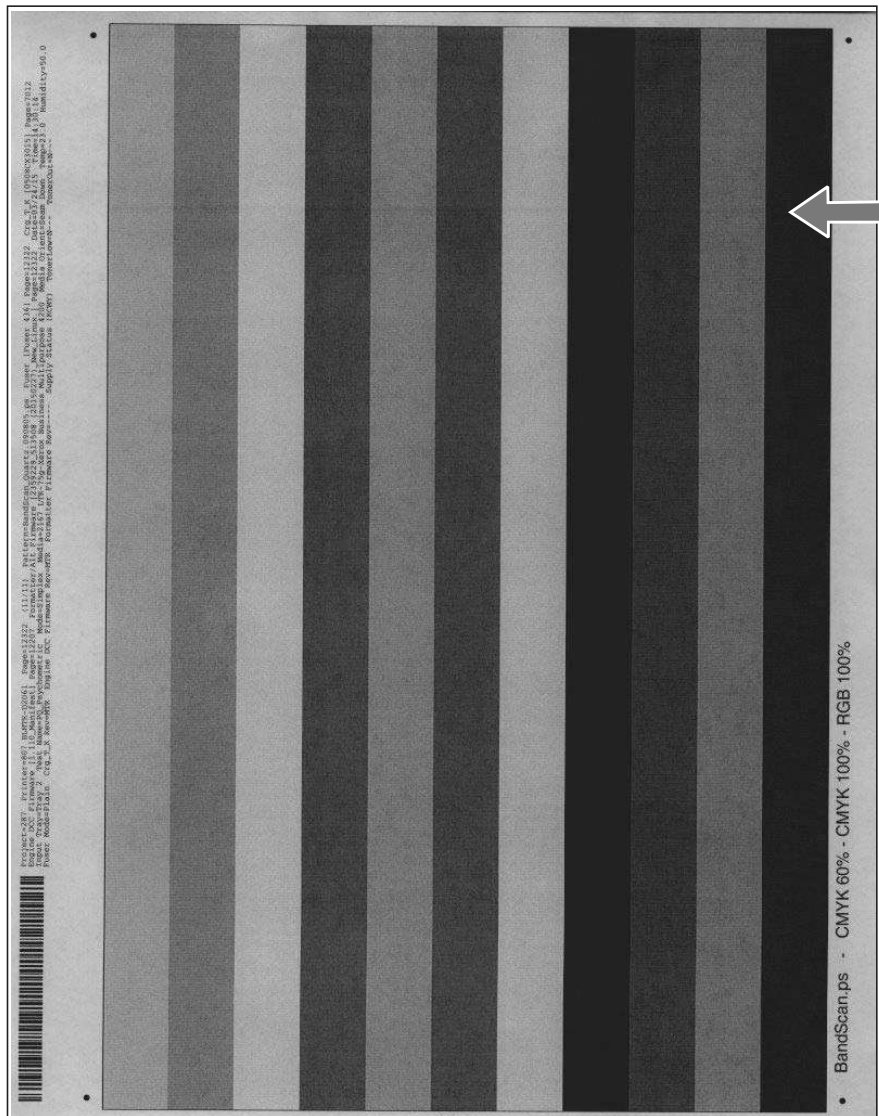
Figure 2-104 Impulse band (leading edge)

This defect appears as a dark and usually sharp band and occurs 49-50 mm (1.92-1.96 in) from the leading edge of the page. This impulse band is caused by the trailing edge of the previous page touching the OPC as it leaves the transfer area, which causes a memory charge disturbance. This defect appears in areas of fill, not in text.

This defect only occurs during continuous printing, on the second and subsequent pages of a job.

- Resend the print job. Impulse bands can be variable.
- **M501:** If the defect appears during continuous printing, from the printer control panel enable the Less Paper Curl print mode.

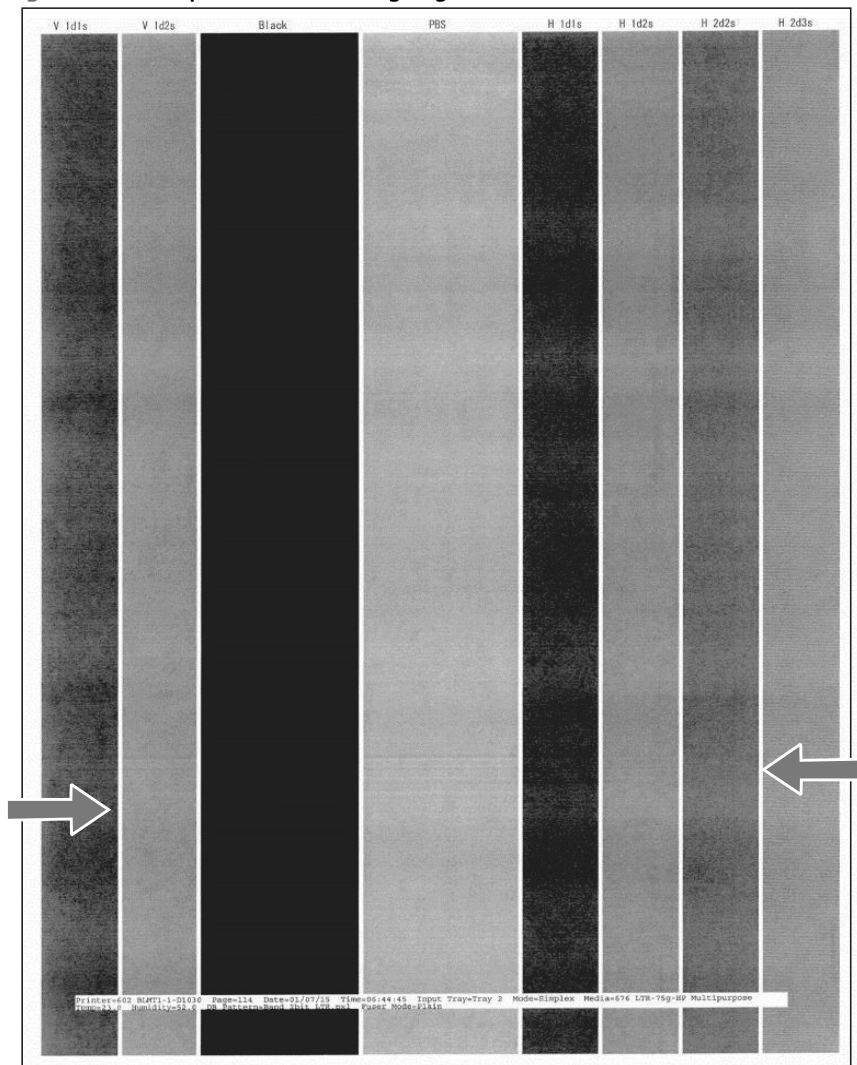
Figure 2-105 Impulse band (trailing edge)

This defect appears as a dark band and occurs 75-82 mm (2.95-3.22 in) from the trailing edge of the page. This impulse band is a development blur which occurs when the paper trailing edge goes through the registration roller. This defect appears in areas of fill, not in text.

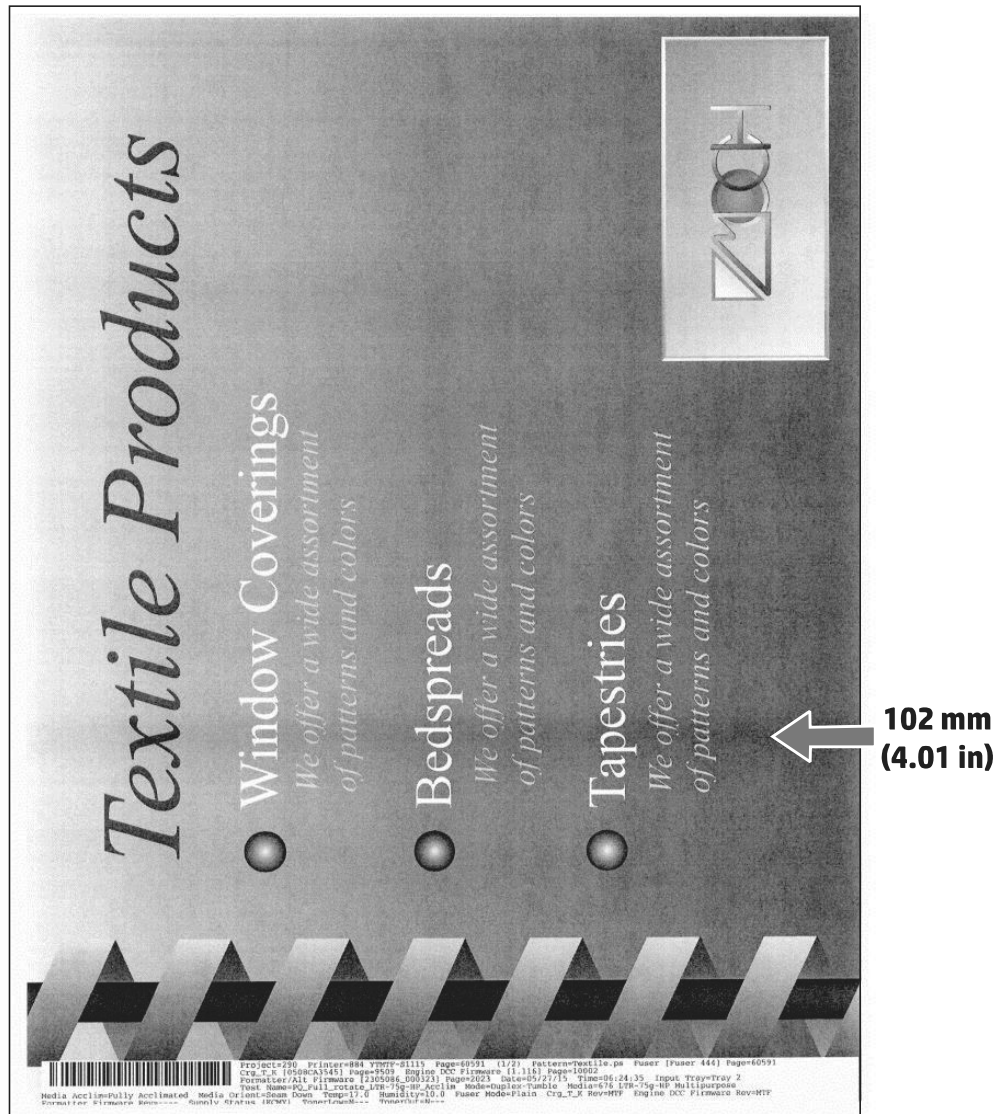
Figure 2-106 Impulse band (trailing edge)

This defect appears as a soft dark band and occurs 102 mm (4.01 in) from the trailing edge of the page. The cause of this defect is poor sliding performance of the transfer bearing (TR bearing) and transfer roller shaft.

This defect is more likely to occur in low temperature/low humidity environments and at cold start conditions.

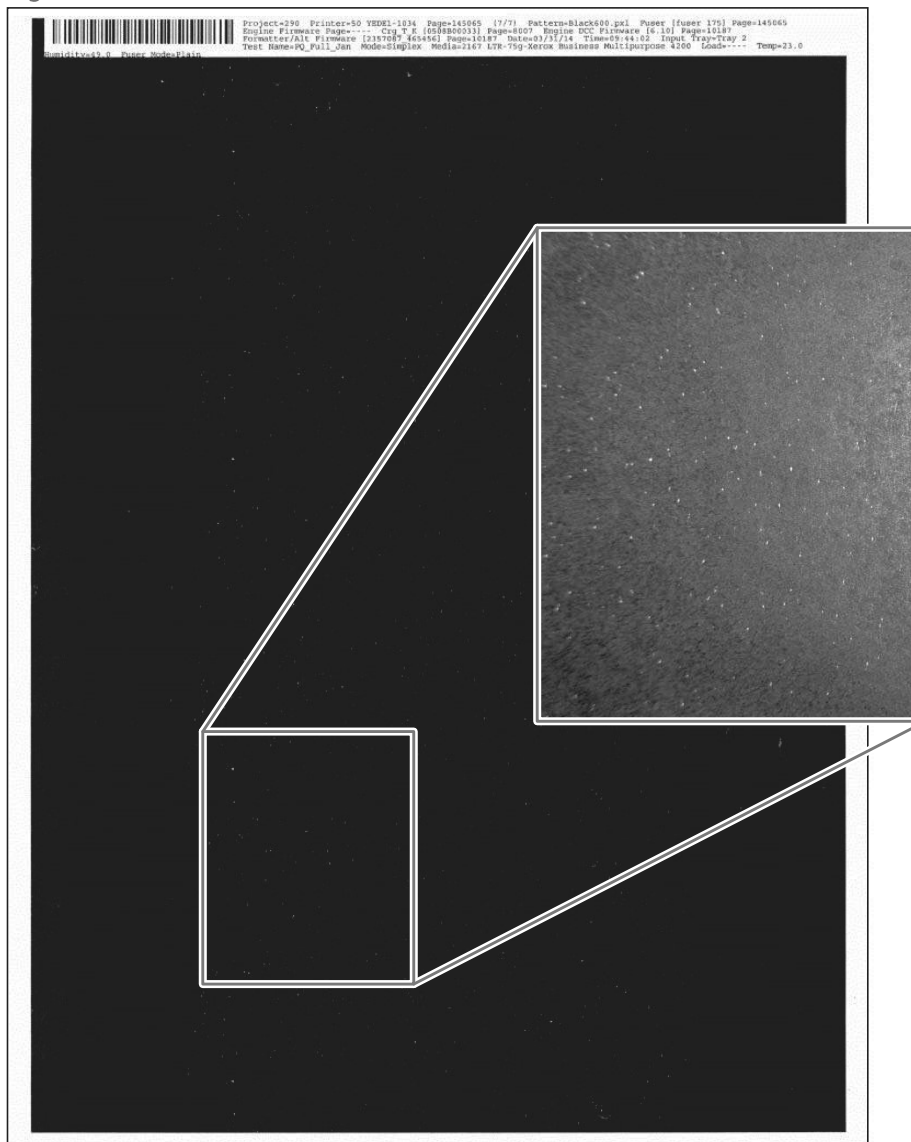
Figure 2-107 Rain-toner attached to the OPC

This defect appears as very small white voids which appear in solid black areas. This issue occurs when toner attached to the OPC cannot be removed by the cleaning blade. This defect appears in areas of solid fill, not in text.

This defect is likely to occur in the later stages of toner cartridge life.

- Verify that the toner is within the expected life, if not replace the toner cartridge.

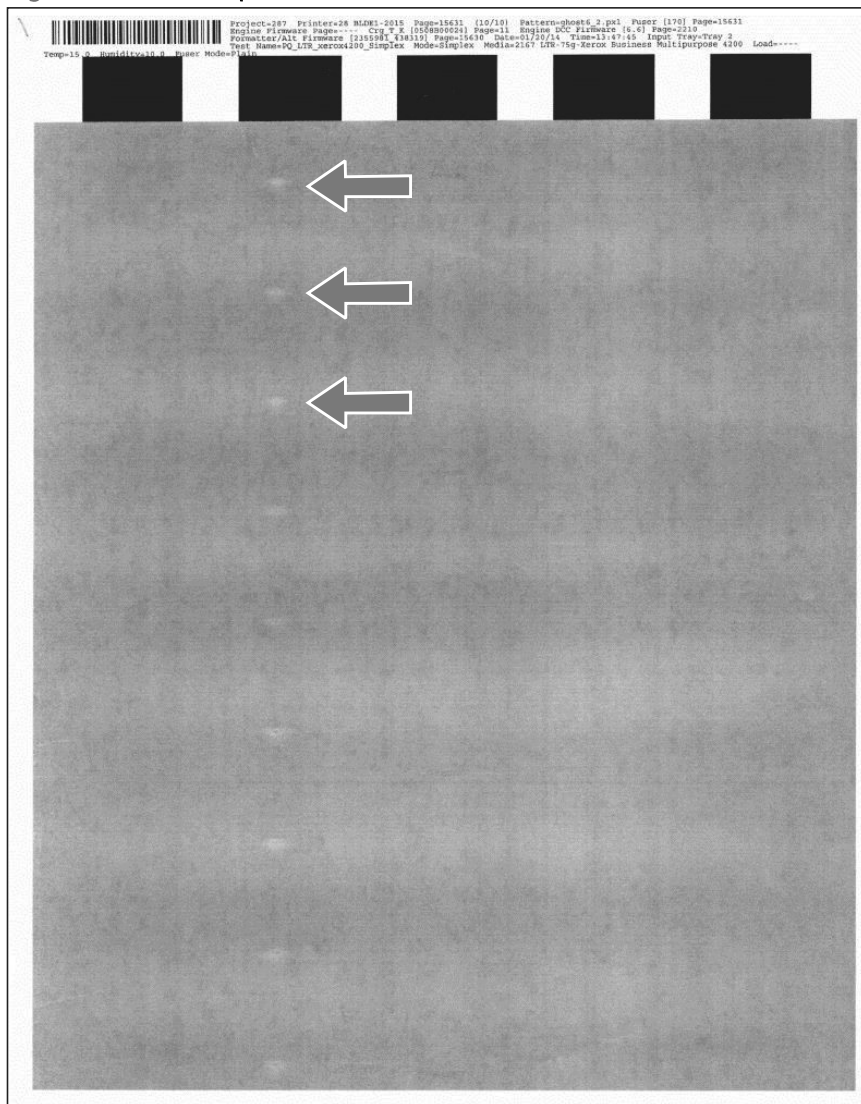
Figure 2-108 Developer defect

This defect appears as a soft white spot which repeats at 27.8 mm (1.09 in) (developer roller) pitch. This defect appears in areas of solid fill, not in text.

This defect is caused by a cartridge cleaning performance issue caused by contamination.

- Resend the print job (the defect should fade with subsequent printed pages).
- If the defect persists, replace the toner cartridge.

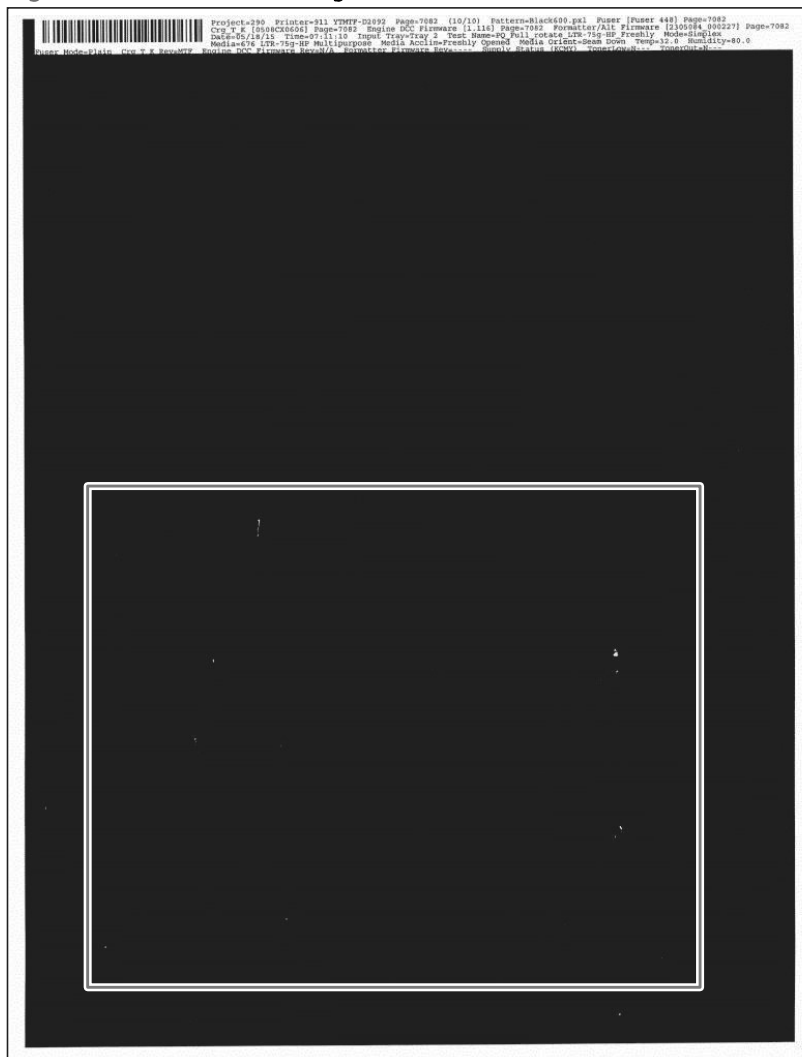
Figure 2-109 Random missing toner

This defect appears as white spots which appear in solid black areas (sometimes with a tail). This defect appears in areas of solid fill, not in text.

This defect is caused by contaminants attaching to the OPC. If the contaminant is large, the size of missing toner will be large.

- Resend the print job. This defect is highly variable.

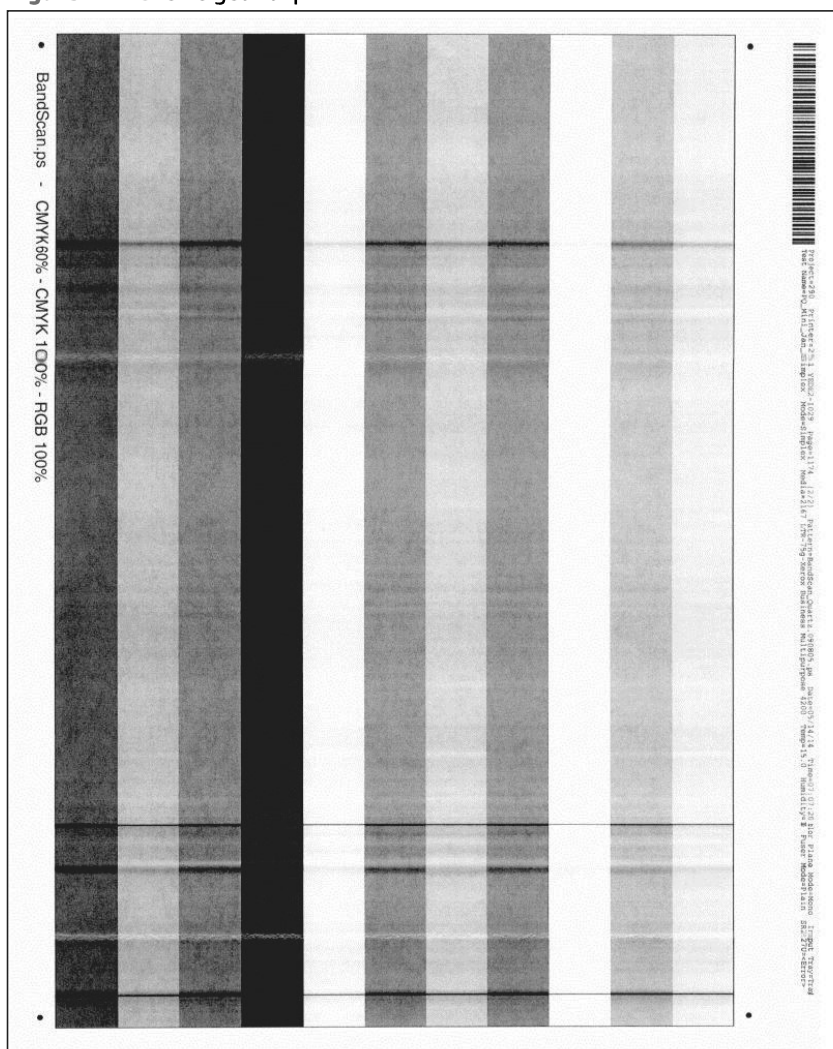
Figure 2-110 OPC gear slip

This defect appears as severe banding. This defect is caused by OPC gear slip (a failed connection between the OPC gear and the drum).

- Resend the print job.
- If the defect persists, replace the toner cartridge.

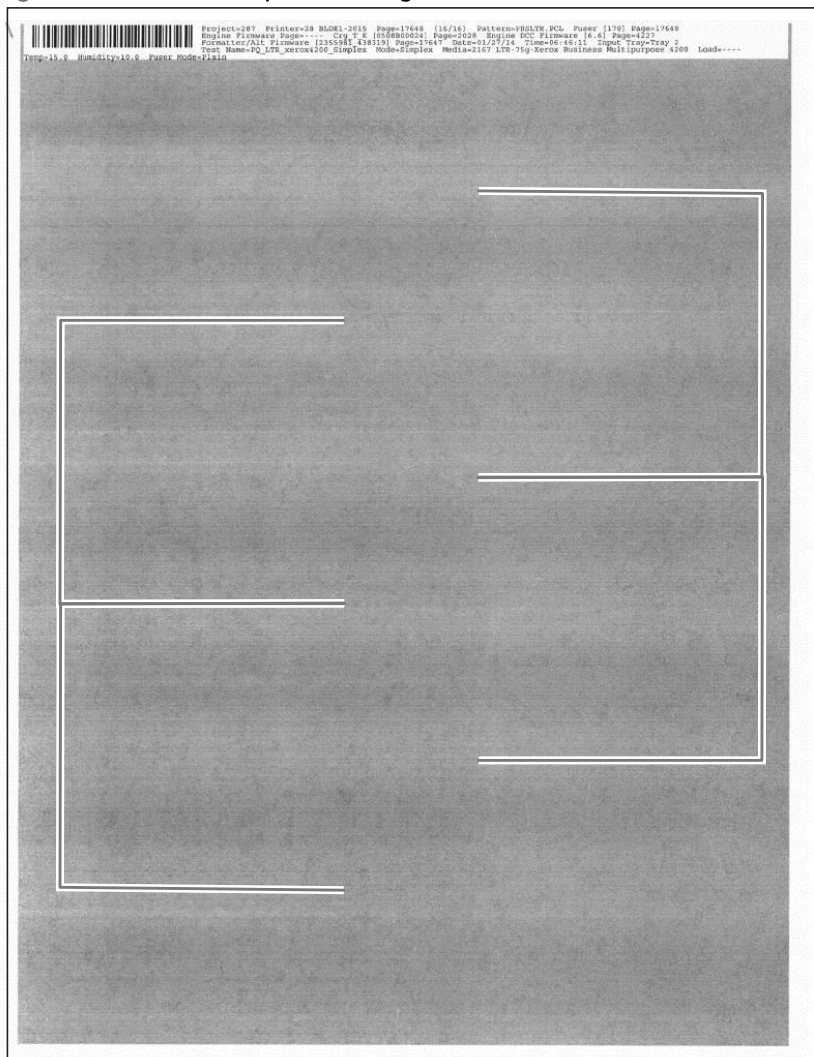
Figure 2-111 OPC wide-pitch banding

This defect appears as overlapping sets of wide-pitch bands (repeating at 75 mm (2.95 in)).

This defect is caused by OPC deformation during the assembly process.

- Resend the print job (the defect should fade with subsequent printed pages).
- If the defect persists, replace the toner cartridge.

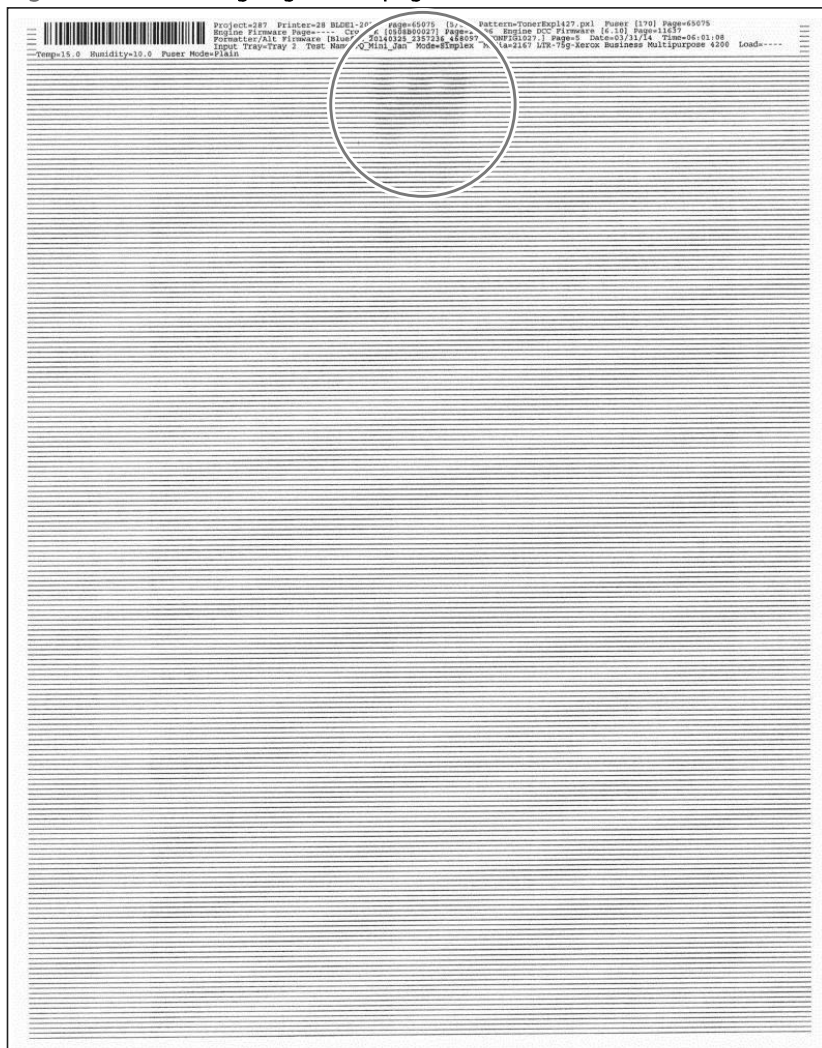
Figure 2-112 Leading edge - mid-page toner scatter

This defect appears as a non-uniform or smear that might appear in the middle of the page at the top of a page. This occurs when the toner scatters at transfer in the area where the media rubs the pick roller and the middle roller. This defect is more likely to occur when media with high resistivity is used. The static charge eliminator (metal brush) on the transfer guide keeps this defect from occurring.

This defect might occur in low temperature/low humidity environments and in cold start conditions.

- Resend the print job (the defect should fade with subsequent printed pages as the printer warms up).
- Try using a different media type.

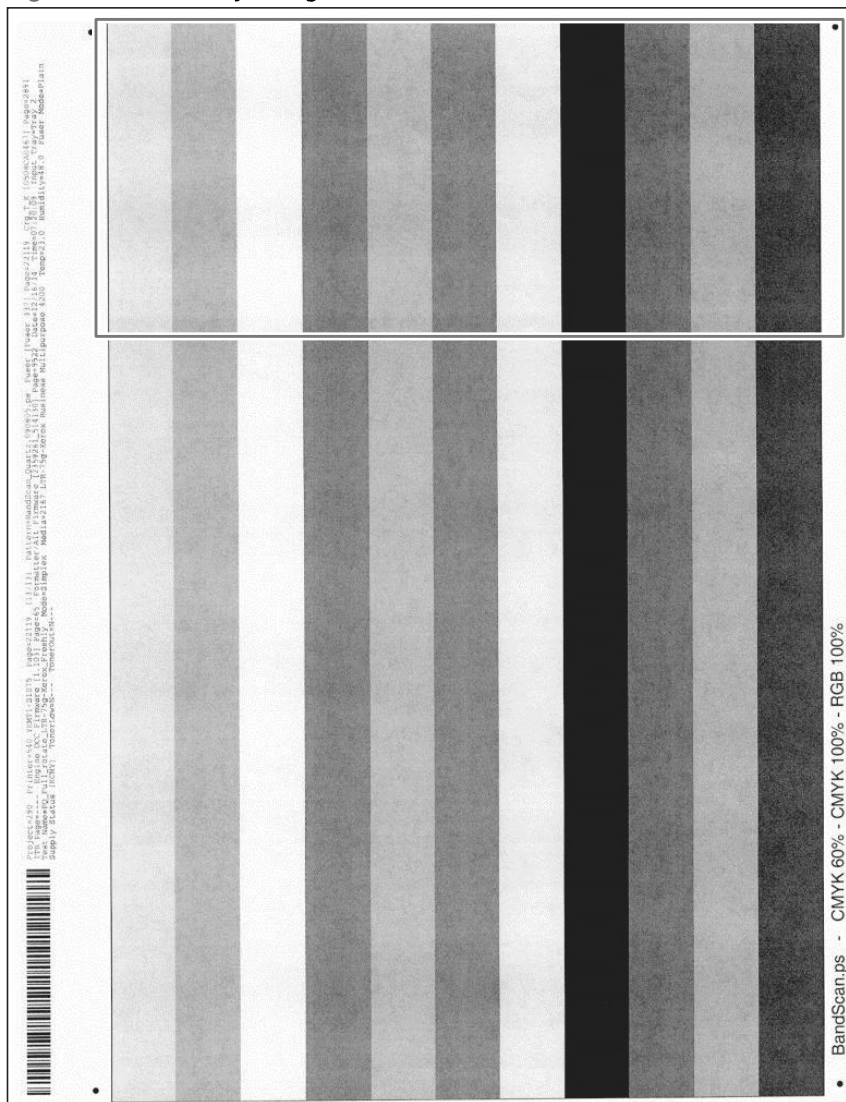
Figure 2-113 Density change

This defect appears as a light image in the first 75 mm (2.95 in) of the page. This defect is created by a charge ghost due to the lack of charge current.

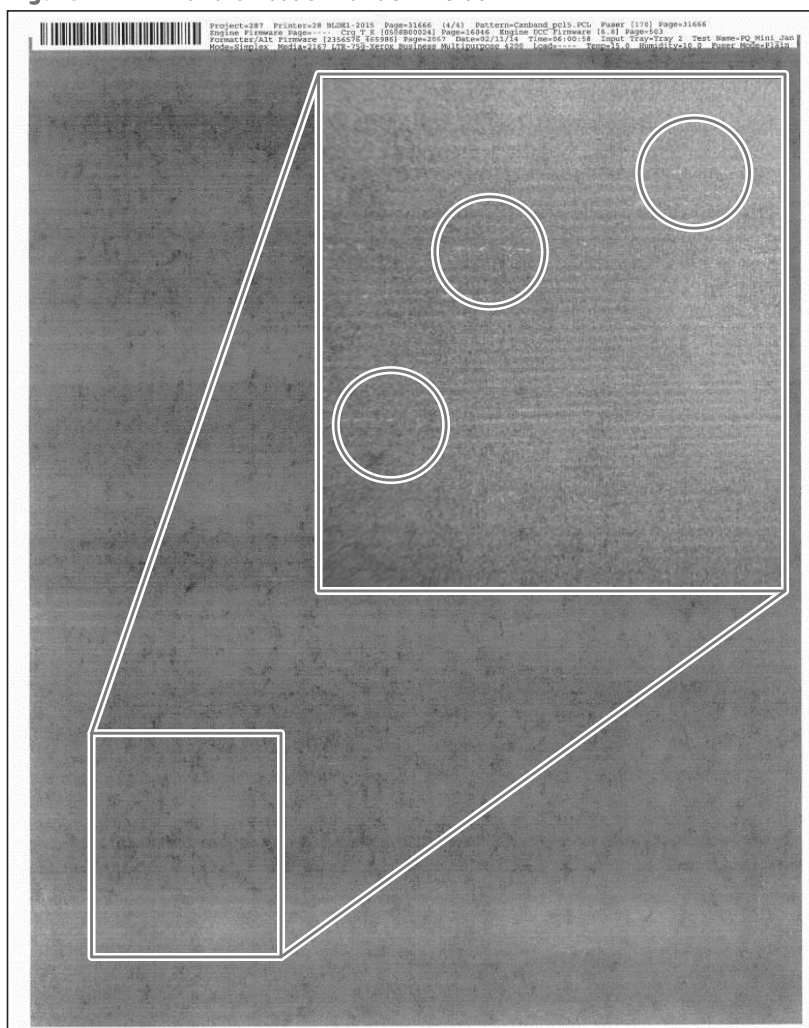
Figure 2-114 Transfer issue - random voids

This defect appears as very small sections of missing toner in random locations on the page. The transfer bias was too strong and caused the missing toner.

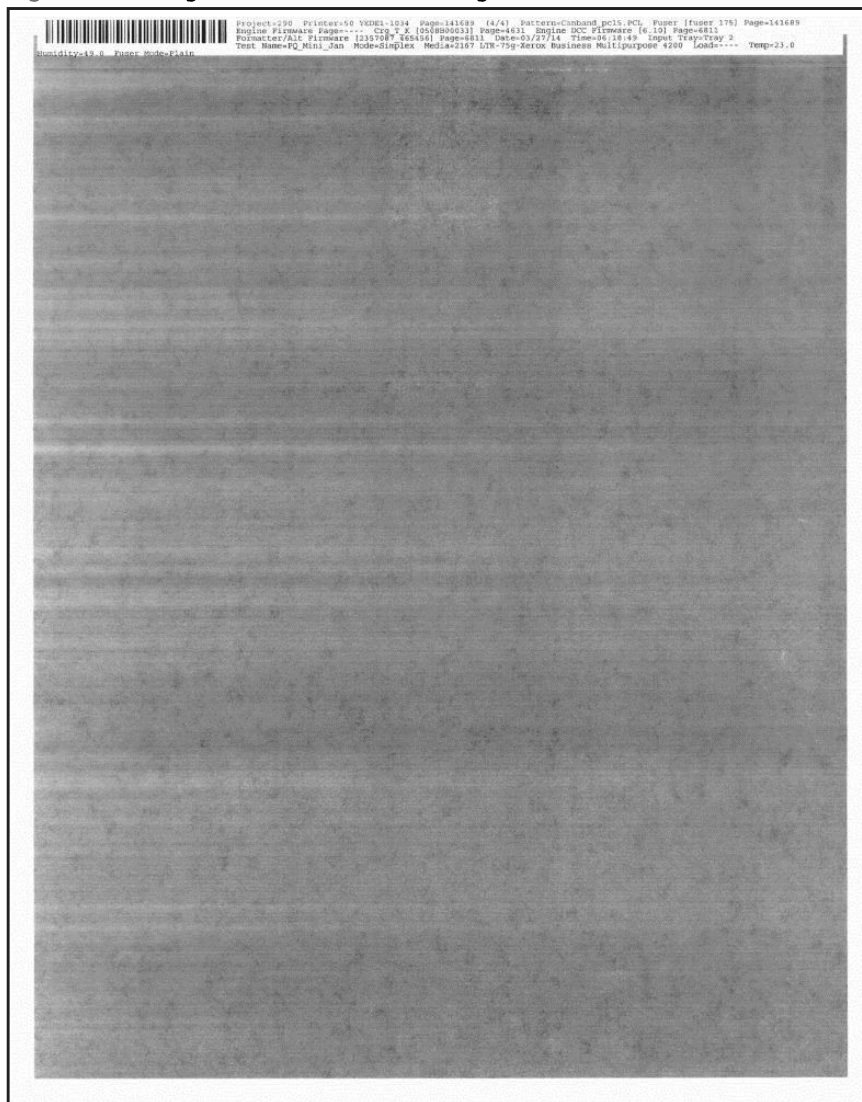
Figure 2-115 Right to left fade and banding

This defect appears as fading and banding at an edge and occurs when the cartridge seals leak allowing toner into the gap between the OPC drum and the SD roller/sleeve. This appears in areas of fill, not in text

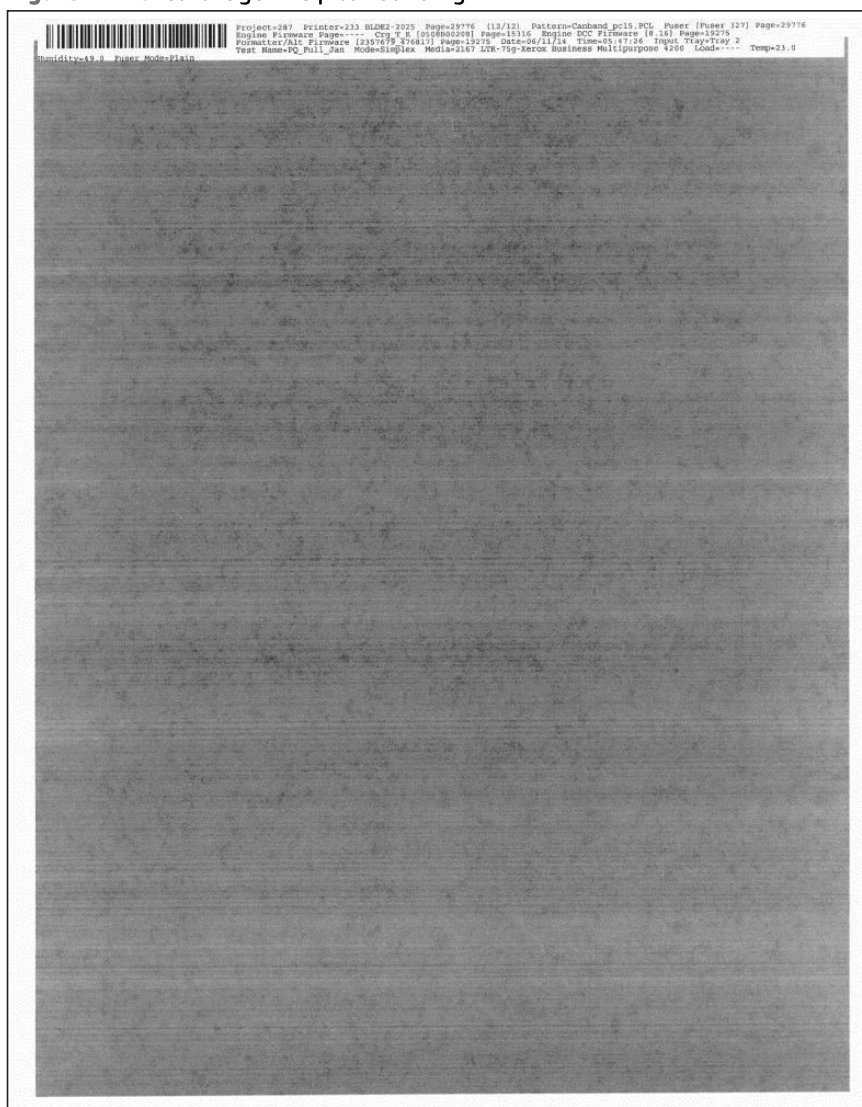
Figure 2-116 Cartridge fine pitch banding

This defect appears as alternating light and dark, evenly spaced, repetitive horizontal lines at a 1.5 mm (0.05 in) pitch. This defect is caused by toner leaking in the drive gear area of the toner cartridge. This appears in areas of fill, not in text.

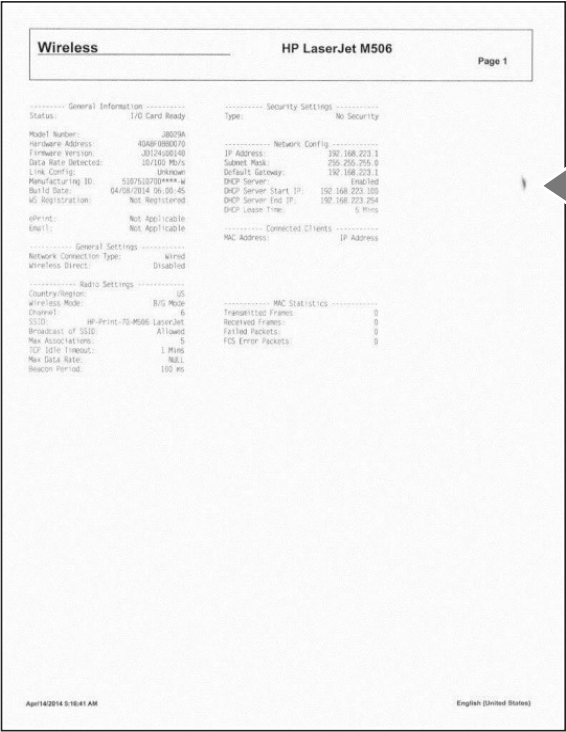
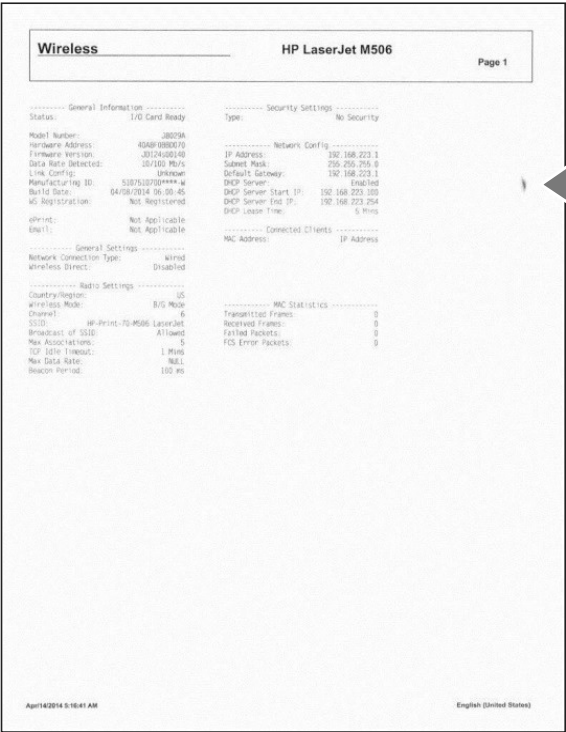
Figure 2-117 IPG repeating defect

This defect appears as a dark crescent moon shape defect and it appears in non-print areas of the page. The defect occurs when the toner is thrown outside the toner cartridge at the stirring pitch due to the waviness of the blow out seal. The waviness creates a gap between sleeve and blow out seal. The cause of the blow out seal waviness is that the edge of blow out seal contacts with the edge of the sleeve/drum spacer.
