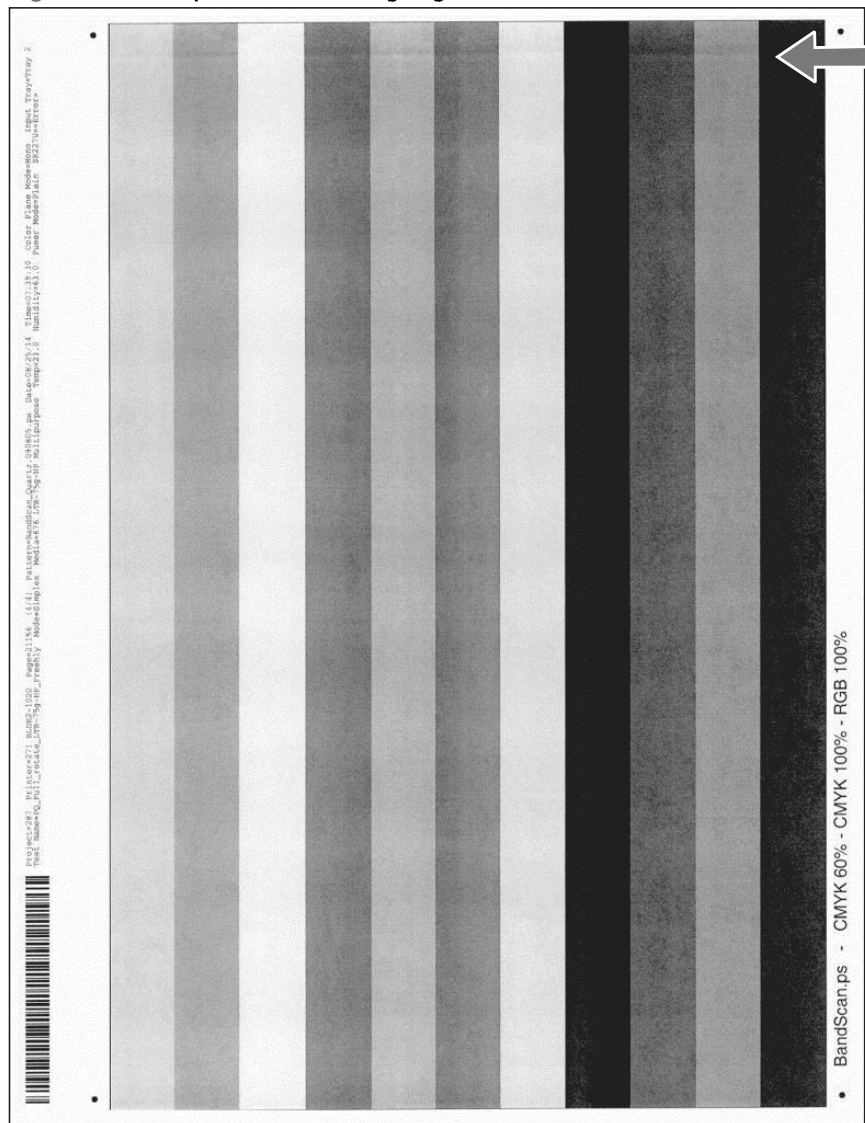
Figure 2-118 Impulse band leading edge

This defect appears as a dark and usually sharp band occurs 15 mm (0.59 in) from the leading edge of the page. This band shows up in areas of fill, not in text.

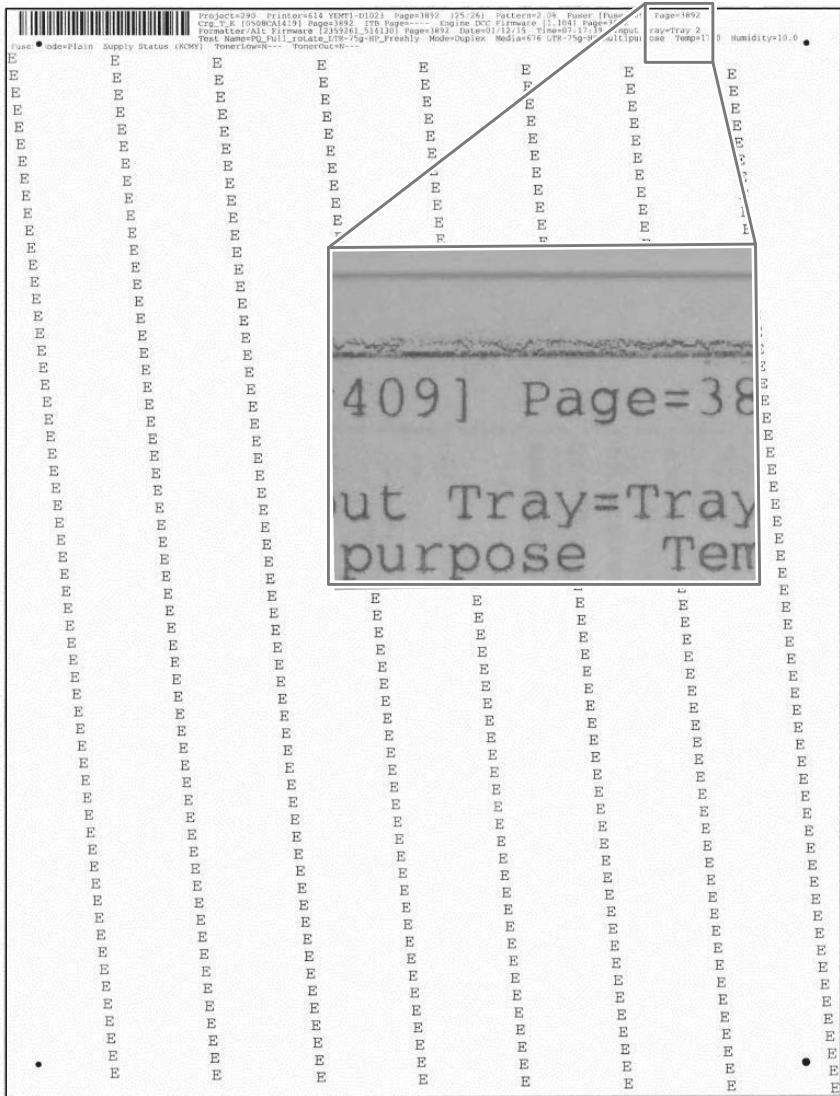
Figure 2-119 Toner in the leading edge margin (fuser slap)

This defect appears as scattered toner which occurs at the leading edge of the page. This defect occurs when the page enters the fuser and the page touches the fuser film which rubs the image on the page.

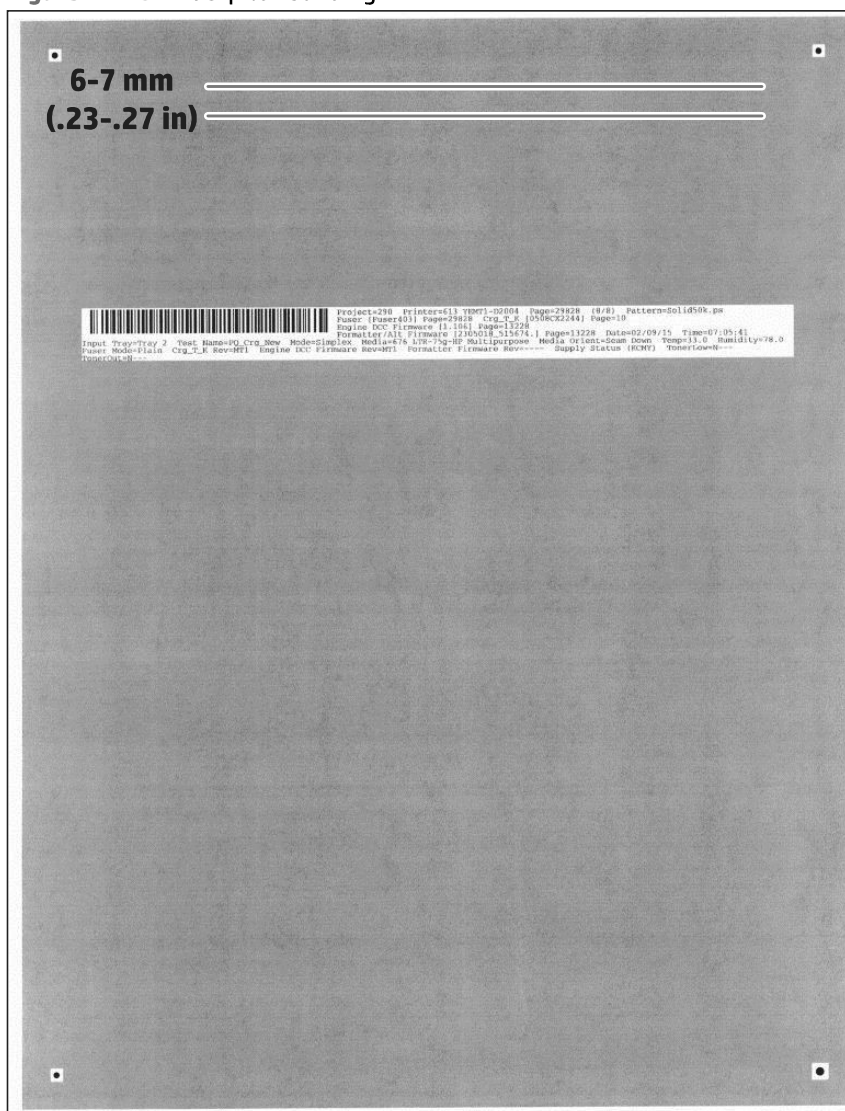
Figure 2-120 Wide-pitch banding

This defect appears as soft bands that repeat at 6-7 mm (0.23- 0.27 in). This banding occurs when the transfer top guide vibrates, which is conveyed to the page as well as the page at the transfer area, causing the uneven density. The left and right edges of the back side of transfer top guide contact with the positioning guide at the transfer frame by the spring at the right edge of the pivot shaft. Since the spring is used only at the right edge, the left side of the alignment feature receives smaller pressing force. When the pressing force is small, the sheet metal vibrates easily. This band shows up in areas of fill, not in text.

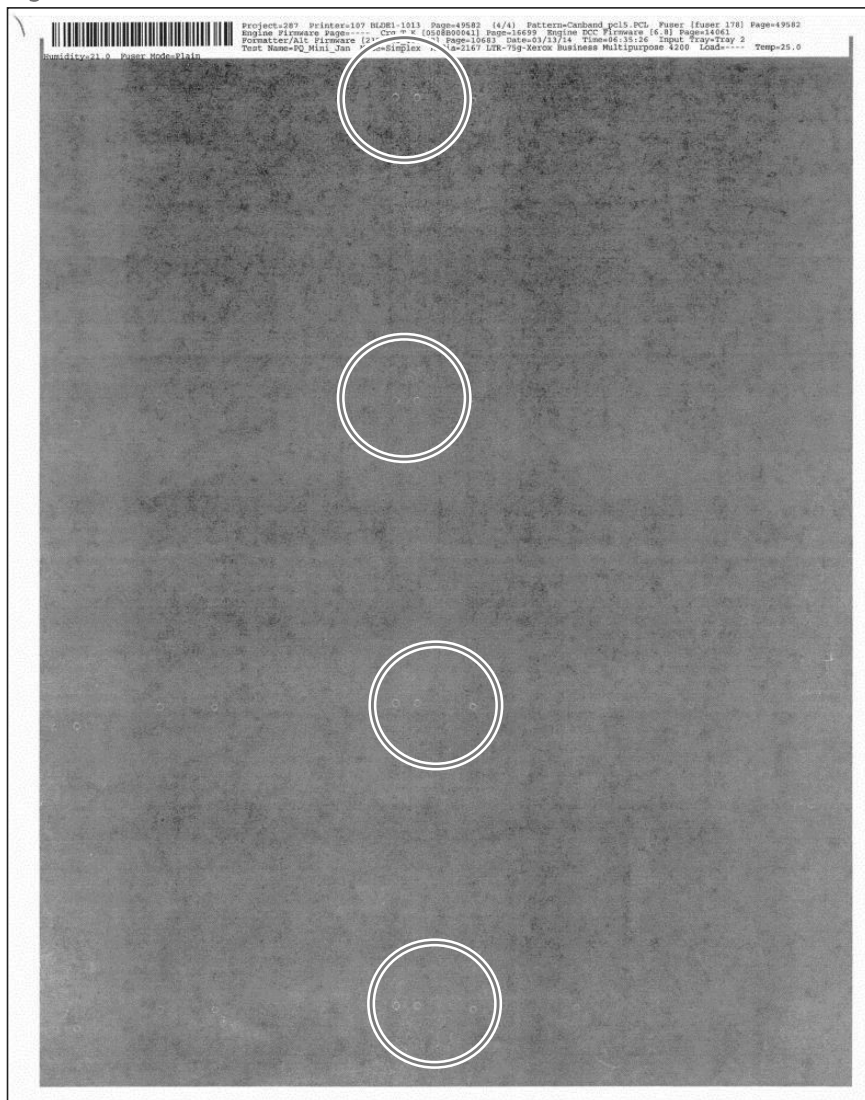
Figure 2-121 Fuser blisters

This defect appears as repeating print defects visible in the image at the fuser pitch of 75.4 mm (2.96 in). These defects were caused by contamination between the films on the fuser.

A defect similar in appearance could occur if a page with sharp objects (for example, staples) is put through the printer.

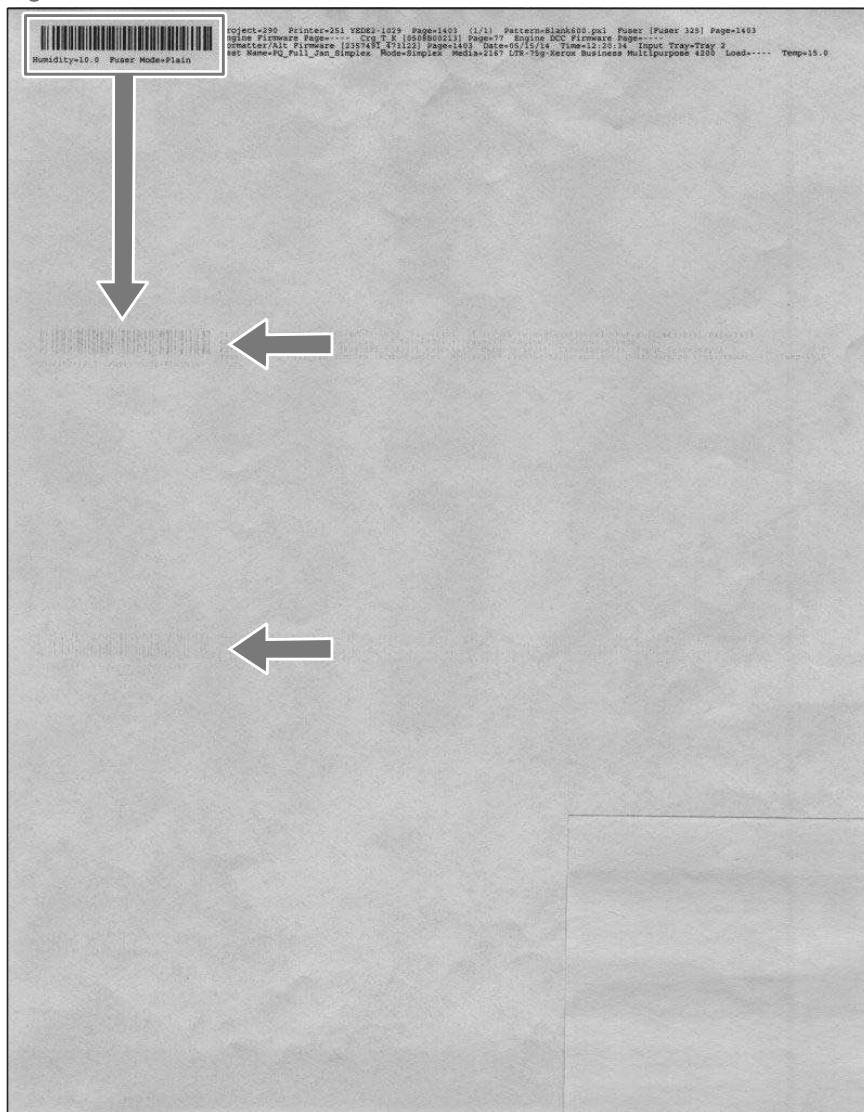
Figure 2-123 Hot fuser offset

This defect appears as slight offset of the image that repeats down the page spaced approximately 75.0 mm (2.95 in) apart. this defect occurred when the fuser thermistor detection temperature did not follow the target temperature.

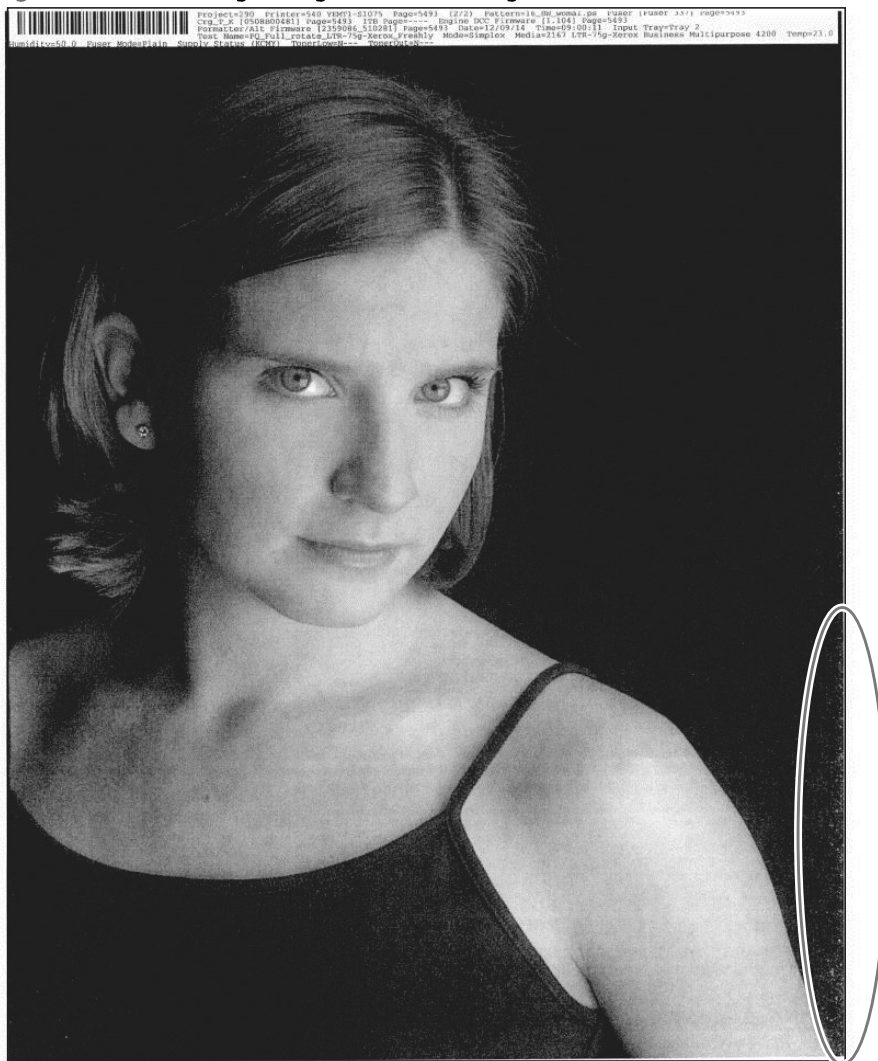
Figure 2-124 Poor edge fixing - within the image assurance area

This defect appears as missing toner inside the 6 mm (0.23 in) image assurance area. Toner rubs off the page. The fuser temperature is too cold.

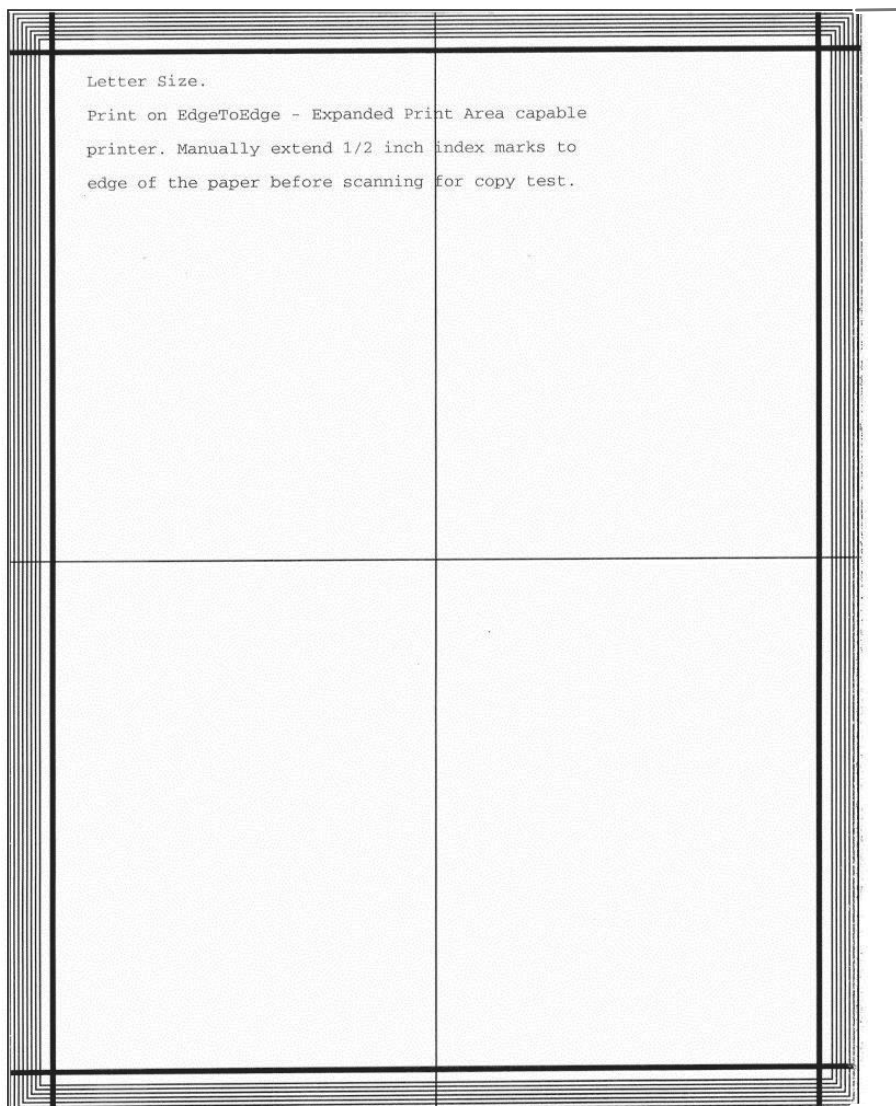
Figure 2-125 Poor edge fixing - outside the image assurance area

This defect appears as missing toner outside the 6 mm (0.23 in) image assurance area. Toner rubs off the page. Poor edge fixing might occur when the printer is using **Edge to Edge** print mode and the image extends past the 5 mm (0.19 in) image assurance area.

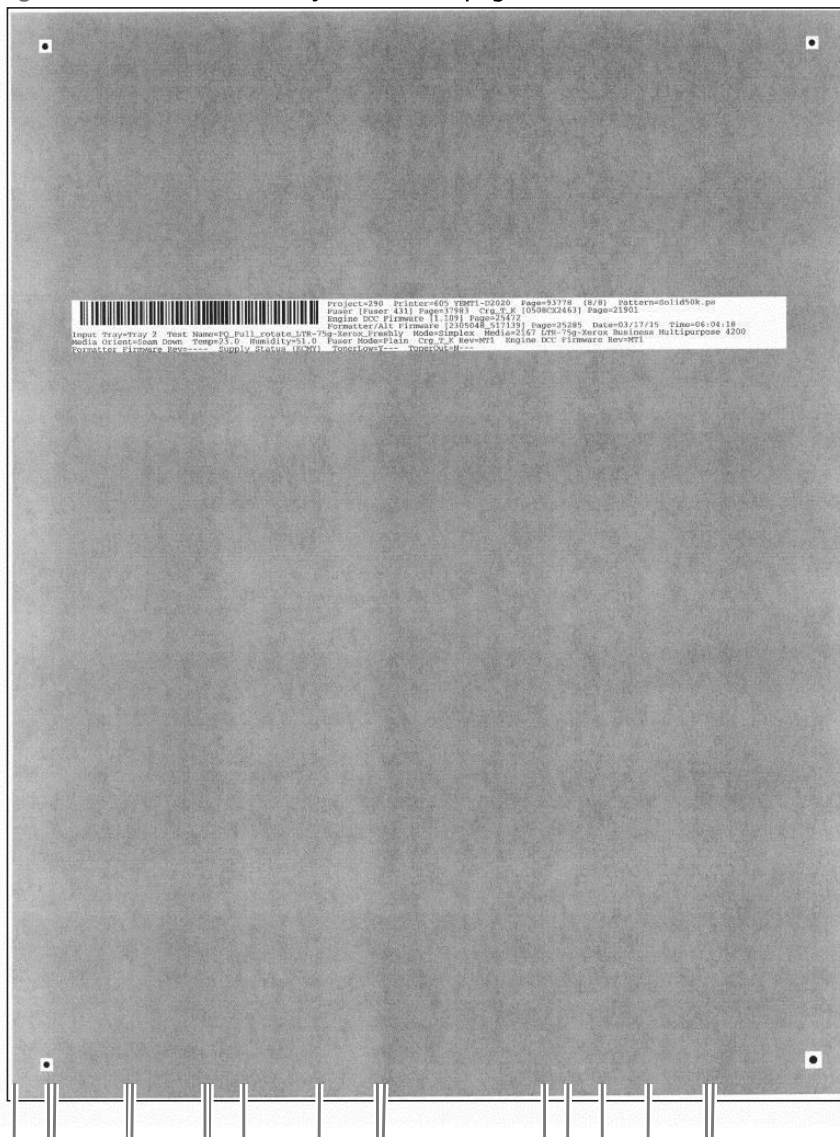
Figure 2-126 Uneven Density - across the page

This defect appears as areas of varying (light/dark) density across the page. This is caused by variation in the position of the stirring system at initial cartridge assembly resulting in toner material attached to the D-blade. Uneven attachment of toner component to D-blade is caused by uneven toner coating on the sleeve during initial sequence. This banding shows up in areas of fill, not in text.

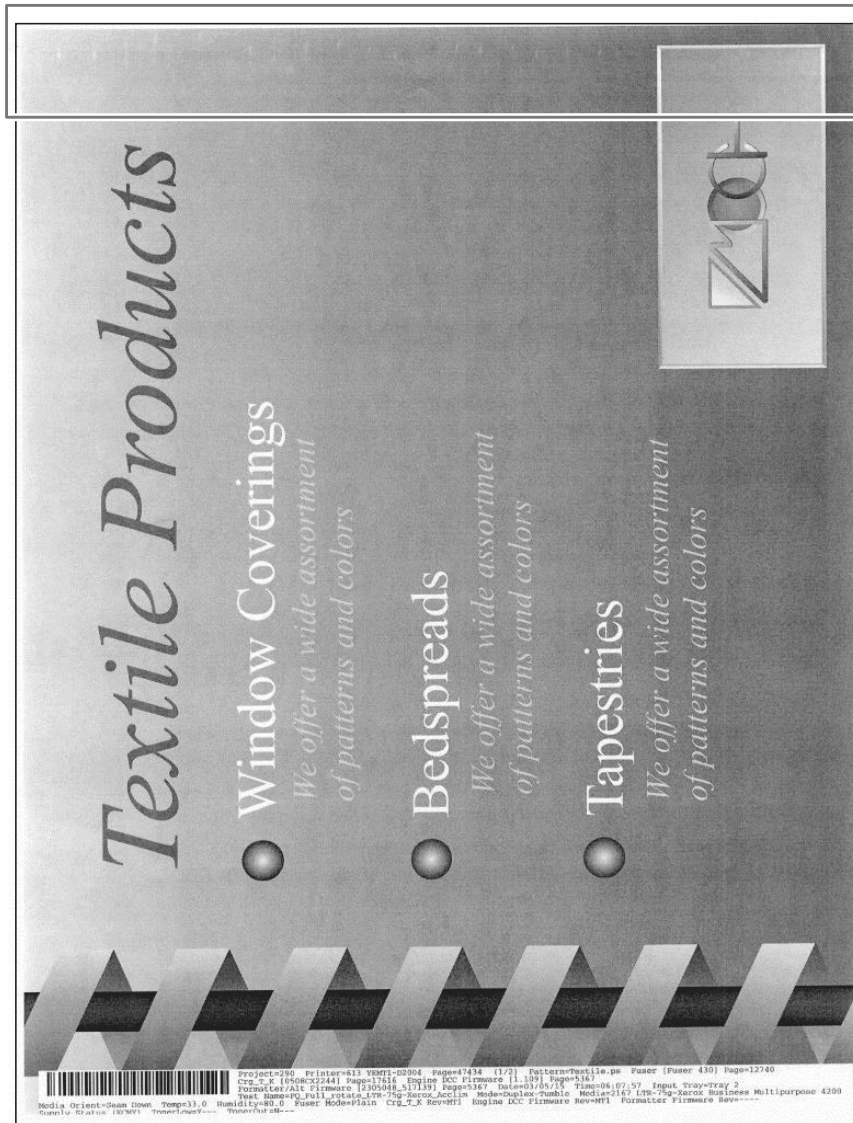
Figure 2-127 Water drop (condensation)

This defect appears as short, soft, light streaks at the top of a page. Condensation collects on the fuser exit guide ribs and transfers to the trailing (unprinted side) of the first pass page of a duplex job. When the duplexed page is printed, the condensation affects the transfer of the toner and causes the defect.

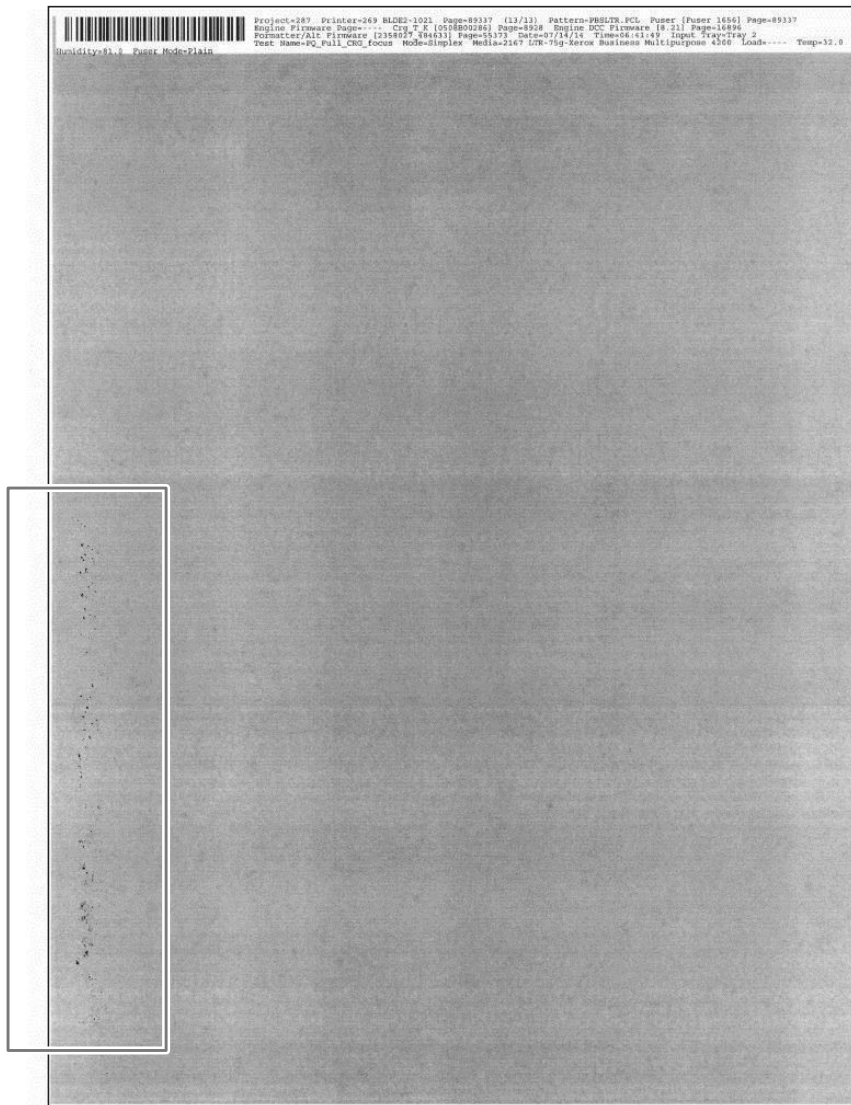
Figure 2-128 Fuser contamination

This defect appears as dark globs of toner observed on the front or back of the page. Toner builds up on the fuser sleeve and pressure roller and comes off on subsequent pages. This defect can be either repeating at 75 mm (2.95 in) or does not repeat.

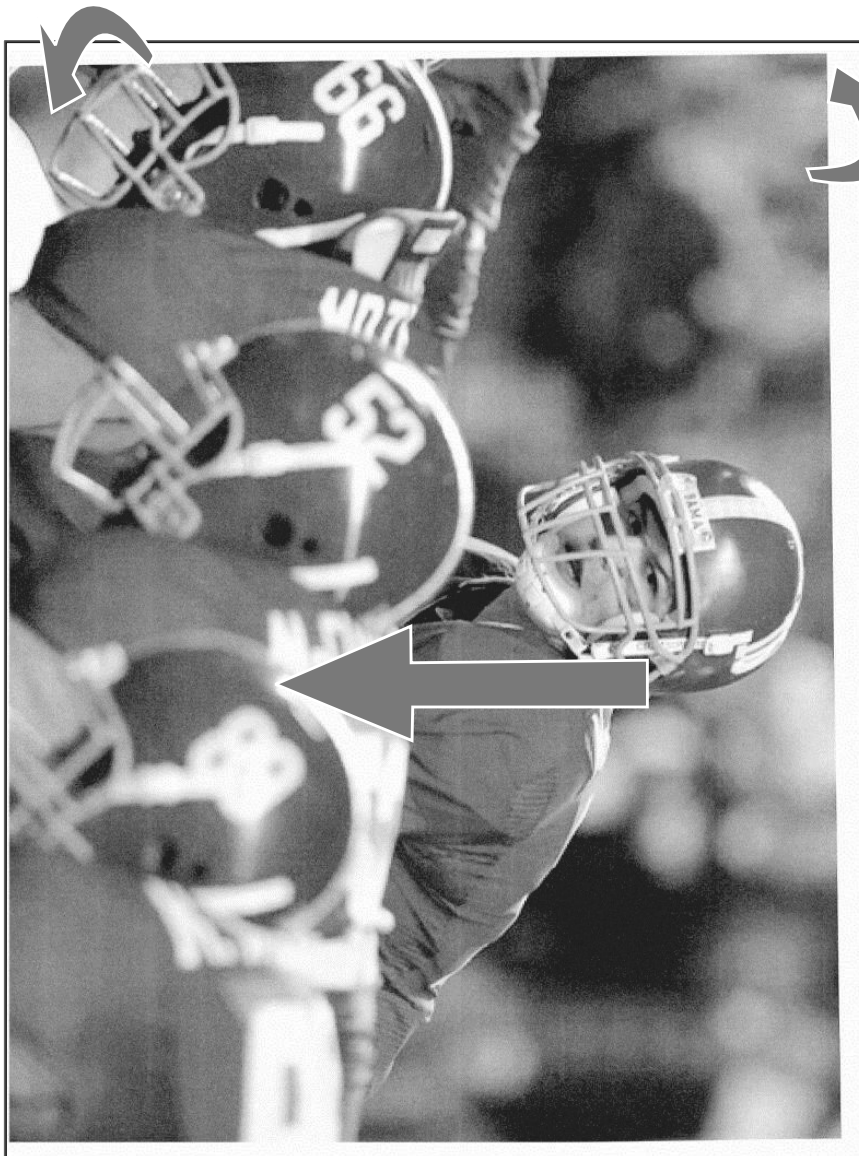
Figure 2-129 Image placement - margins and skew

This defect appears as image that is not centered or skewed on the page. The media is not positioned properly as it is pulled from the tray and goes through the paper path.

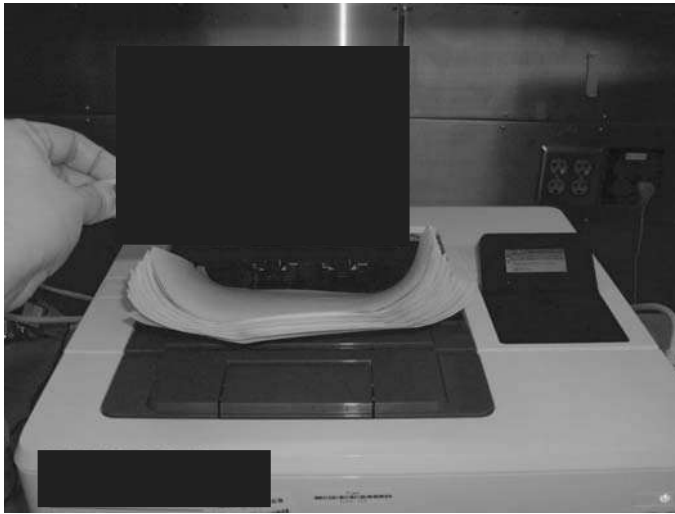
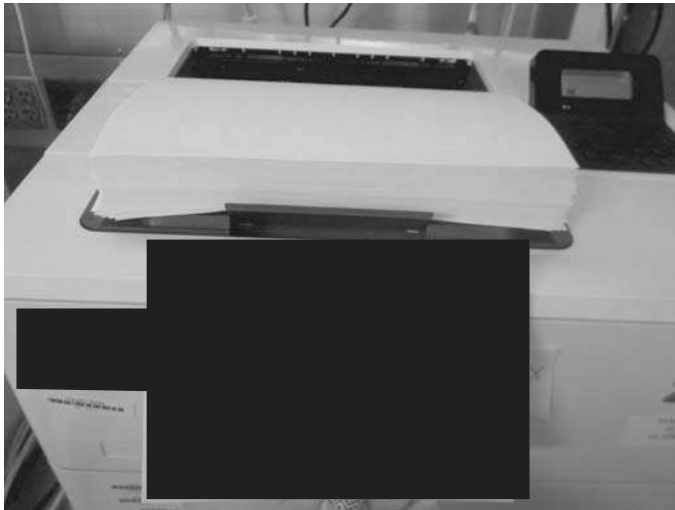
Figure 2-130 Output curl

This defect appears as printed pages are curled. Two types of curl are possible:

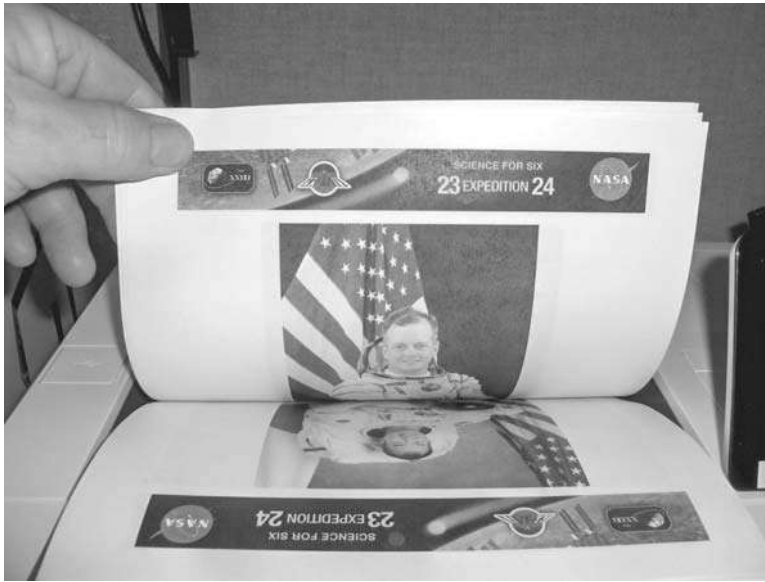
Figure 2-131 Sticky output

This defect appears as output pages that stick together when printing heavy coverage images in duplex mode. When printing large jobs the output stack retains enough heat that the toner on the top page does not cool sufficiently and can be tacky in heavy coverage areas. When the next page is output if there is heavy coverage that lands on the top page in the stack, the toner-to-toner contact might stick.

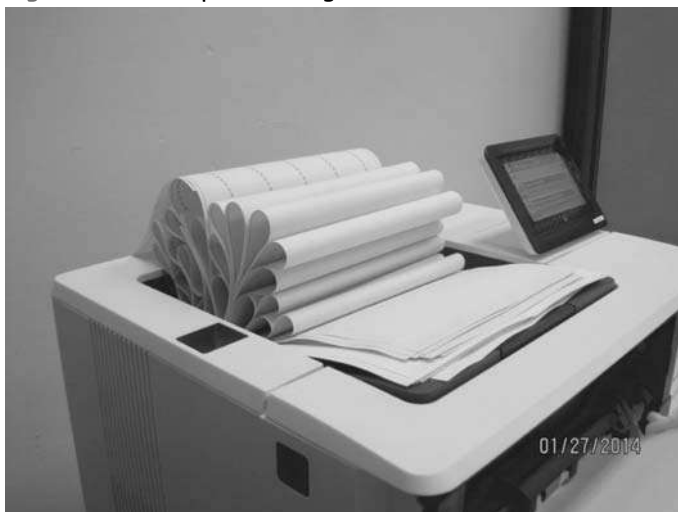
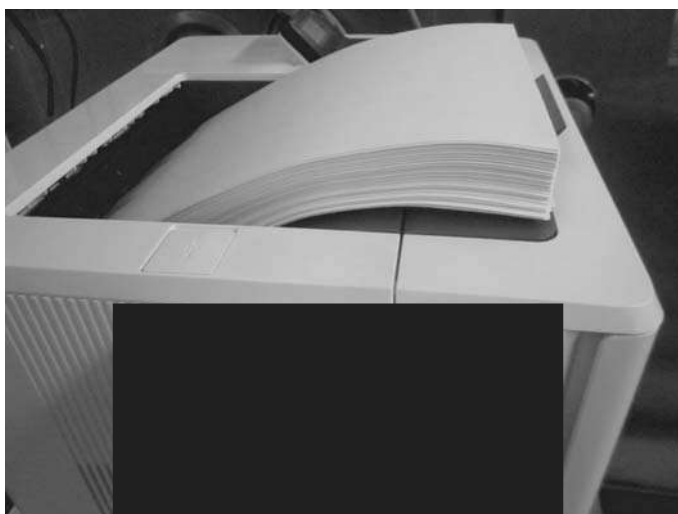
Figure 2-132 Output stacking

This defect appears as output pages that do not stack properly in the output bin. The stack may be uneven or skewed or pages could be pushed out of the tray and onto the floor.
