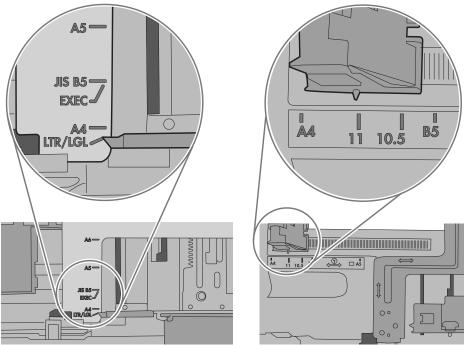
Figure 2-77 Paper Tray guides

Remove the paper from the tray and check that the paper tray size guides are properly set and that the 4. tray is not over filled with paper.

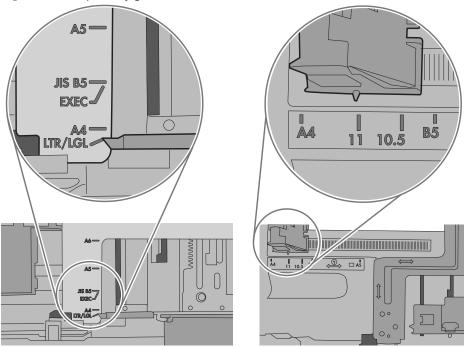
Figure 2-79 Paper Tray guides

3. Remove the paper from the tray and check that the paper tray size guides are properly set and that the tray is not over filled with paper.

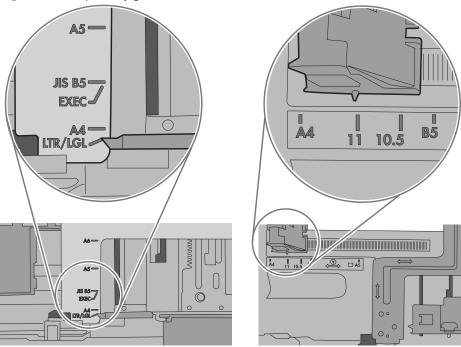
Figure 2-81 Paper Tray guides

3. Remove the paper from the tray and check that the paper tray size guides are properly set and that the tray is not over filled with paper.

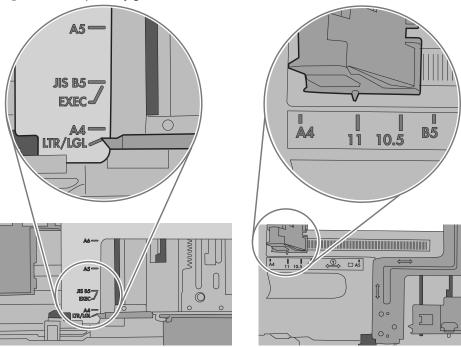
Figure 2-83 Paper Tray guides

3. Remove the paper from the tray and check that the paper tray size guides are properly set and that the tray is not over filled with paper.

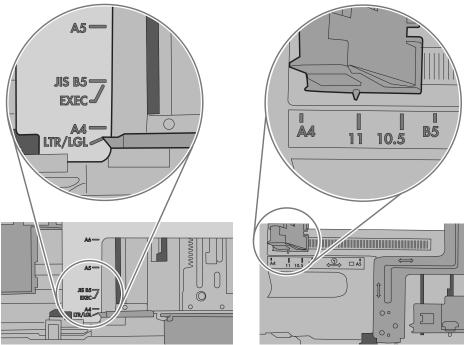
Figure 2-85 Paper Tray guides

3. Remove the paper from the tray and check that the paper tray size guides are properly set and that the tray is not over filled with paper.

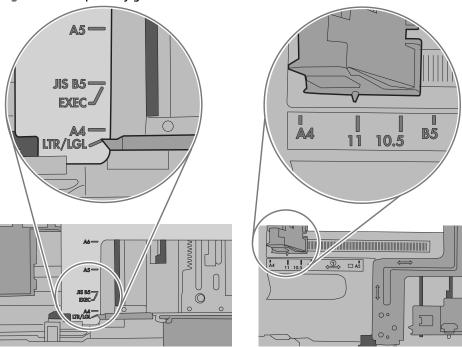
Figure 2-87 Paper Tray guides

> Remove the paper from the tray and check that the paper tray size guides are properly set and that the tray is not over filled with paper.

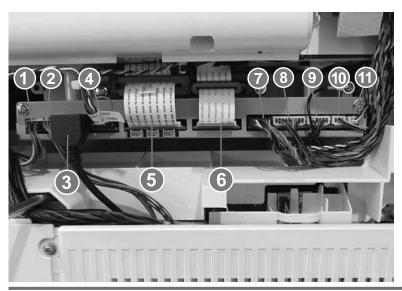
1	Stapler power
2	SCB Power (24v)
3	PAB to SCAM Communication (HDMI)
4	Flatbed sensors (ADF open and Flatbed media length_ and Cave LED
5	Flatbed (S1) Flat flexible cable (Scanner data and flatbed motor)

6	ADF (S2) Flat flexible cable (Scanner data)
7	ADF Motors (Feed and Deskew)
8	ADF Sensors (Prescan, media present receiver and top hatch)
9	ADF Ultra sonic sensor receiver and deskew sensor
10	LTR/LGL (letter/legal) Input tray sensor
11	Ultra sonic sensor transmitter

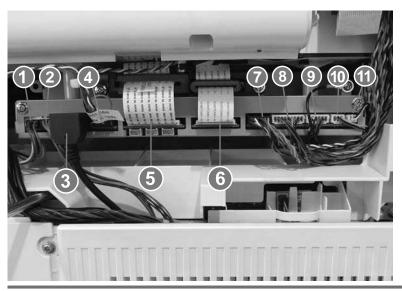
1	Stapler power
2	SCB Power (24v)
3	PAB to SCAM Communication (HDMI)
4	Flatbed sensors (ADF open and Flatbed media length_ and Cave LED
5	Flatbed (S1) Flat flexible cable (Scanner data and flatbed motor)

6	ADF (S2) Flat flexible cable (Scanner data)
7	ADF Motors (Feed and Deskew)
8	ADF Sensors (Prescan, media present receiver and top hatch)
9	ADF Ultra sonic sensor receiver and deskew sensor
10	LTR/LGL (letter/legal) Input tray sensor
11	Ultra sonic sensor transmitter

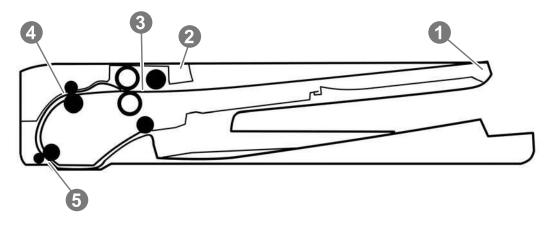
### Sensor location 4

Paper pick was initiated, but the page didn't did not make it to the pick success sensor.

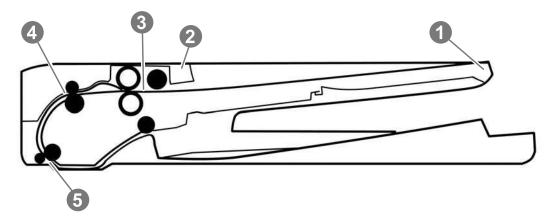
Between sensor location 4 and 5

The paper passed the pick success sensor, and then jammed in the document feeder paper path.

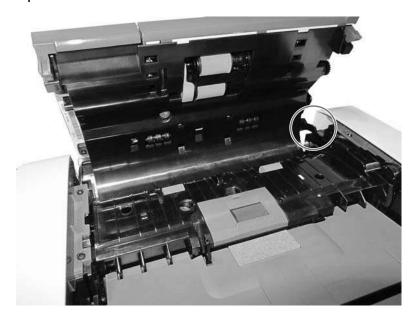
- Verify that the jam access cover is closed.
- 2. Verify that the flag is not broken off. Open and close jam cover and if sensor status does not change then replace the ADF.

- Administration
- Troubleshooting
- **Diagnostic Tests**
- **Scanner Tests**
- Actuate the pick-success sensor. If the sensor does not show functionality when tested, verify connectors (9) Ulta sonic sensor.
